APPENDIX C5
Arboricultural Assessment

Final Arboricultural Survey & Development Report

National Football Centre. Proposed Hotel, Sports Facilities and Associated Development

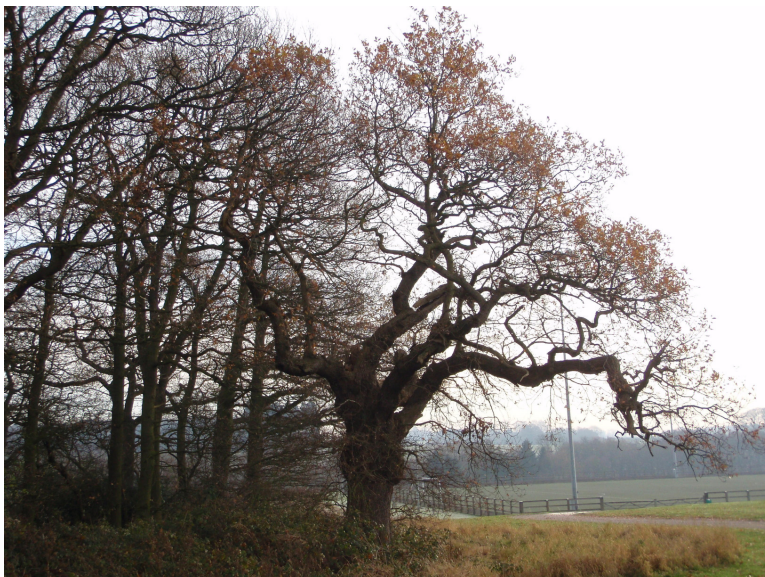
The two identified trees are of a condition conducive with their incredible age, and as such, areas of deadwood, fracture stubs and cavity development, both within their crowns, main stems and major scaffold branches are evident. The trees appeared to be actively growing and are establishing good bud development, an indication that they are potential in a healthy condition, bearing in mind their showing a slowing declining state of health. It is recommended that all of the trees, should be re-inspected during the summer of 2010, in order to obtain a fuller picture of their overall health.

Tree Number 4820
 Veteran Oak located towards the northwestern corner of the woodland.
 It is recommended that a post and rail fence be constructed around the tree at a distance of 1.5 times tree height to create a total exclusion zone, to encourage the development of 'natural regeneration' of a known provenance. Due to the close proximity of the road, this will not be feasible on the trees western side.

It was apparent that the trees appear to have coped well with the alterations that have occurred in recent years to their localised environment, and as such it is recommended that a 'None Intervention' management strategy continue to be employed around these two trees. It is recommended, that this should comprise of the construction of a post and rail fence erected at a distance of 1.5 times tree height, or at their maximum 'Root Protection Area' (RPA) requirements, as specified by BS 5837 (2005), which ever is the greater distance.

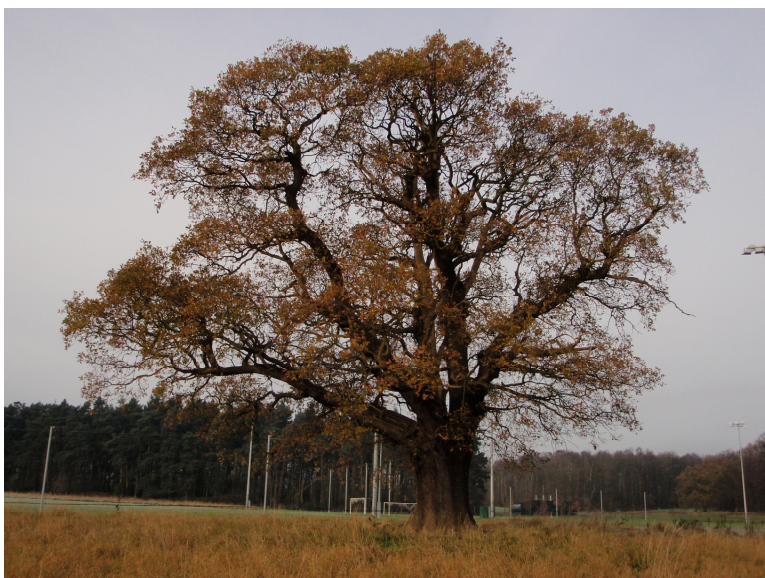
Tree Number 4892.
 Stand alone Veteran Oak located within an area of semi rough grassland.
 It is recommended that a post and rail fence be constructed around the tree at a distance of 1.5 times tree height to create a total exclusion zone, to encourage the development of 'natural regeneration' of a known provenance

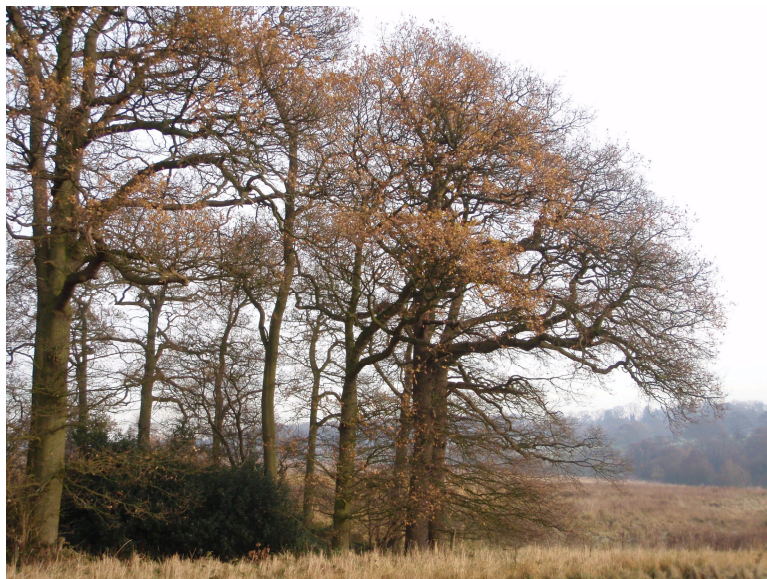
In additional to a small number of trees recommended for removal based on their poor and declining overall condition, the greater majority of the dominant woodland trees contain varying amount of deadwood, fractured and part fractured and hanging limbs within their crowns (Ref Arboricultural Survey).

General view of the western side of the woodland area.

It is therefore recommended that due to the woodlands close proximity to the complex there will be a necessity for the implementation of extensive remedial tree surgery works to all trees, to remove all deadwood, fractured and hanging branches.

It is further recommended that the woodland trees become the subject of a rolling re-inspection programme, in order that their health can be regularly assessed.

It is further recommended that additional under-story work be implemented, through the management and control of the 'Bramble' and Elderberry, and through the 'light' scarification of the ground surface to encourage the development of 'natural regeneration' from the dominant Oak trees.

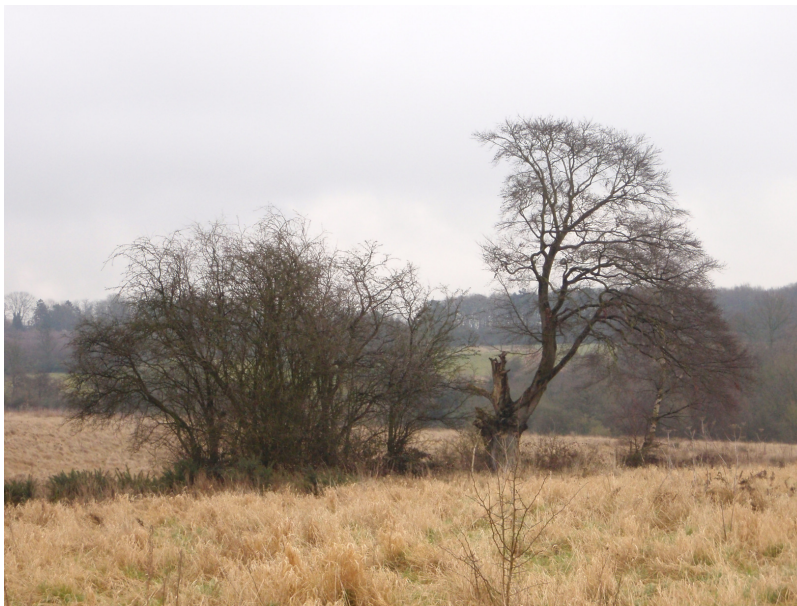
A general view of the three trees, The photograph clearly indicates the structurally poor condition of the Beech tree.

It is apparent that the tree has suffered major structural limb loss on its northern side, resulting in the loss of approximately 50% of its crown. It was further apparent that decay had become established within the resultant wounds and throughout the tree's main stem, further reducing the structural integrity of the tree's remaining major limbs.

It is therefore concluded that this tree is in a state of terminal decline and has a very limited life expectancy, and could suffer imminent failure of its remaining limbs and crown sections.

It is considered that although the Hawthorn does provide valuable nesting opportunities, it has no intrinsic aesthetic value, further more, the adjacent Beech tree is in a structural very poor condition, and would constitute a major public safety hazard if retained.

It is therefore recommended that all three trees should be removed and their loss mitigated for through the implementation of an appropriate landscape design scheme.

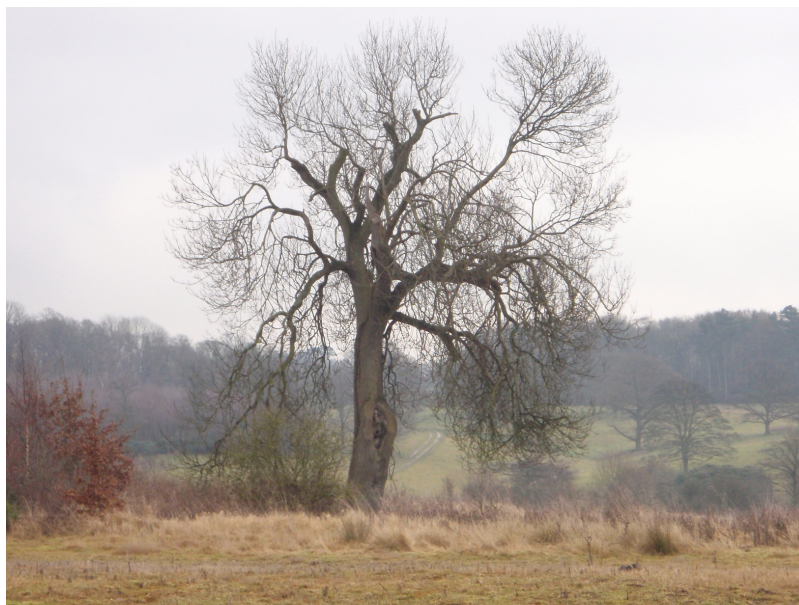
The tree's main stem shows two large fracture wounds on its western and southern sides, both of which are located at approximately 5 metres. It is considered that the large wounds are the result of historical co-dominant and/or major lateral limb failure. It is apparent that the resultant wounds exhibit symptoms indicating the presence of internal decay and cavity development. It is anticipated that a large central column of decay/decay staining may have occurred within the tree's main stem, the result of which may have a potential influence on the trees long-term structural stability. The trees upper crown show evidence of additional limb failure wounds with the potential for additional areas of decay to be present.

It is considered that due to the trees age, historical storm damage and its exposed location, there is the potential for further storm damage to be inflicted, especially given that the tree has several long exposed lateral limbs.

Tree Number 4896.
The photograph clearly shows the large wound on the northern side of the trees stem, as well as the upper crown fracture wounds.
It is considered that retention of this tree is not viable within an area of high public access, due to its poor and declining condition

regard to 'bat' habitats or Owl nesting sites. It is therefore suggested that, from a landscape and wildlife habitat perspective, the tree warrants the undertaking of remedial tree surgery work to rectify and reduce the potential for further major limb failure, through the undertaking of a carefully planned crown reduction programme that will reduce the crowns physical weight and its foliage 'sail' area.

It is recommended that the proposed crown reduction work could be undertaken with the view of increasing the trees wildlife habitat value, through the use of planned 'tear' and/or 'coronet' cuts. The use of which tries to 'mimic' natural limb failure, and produce wounds that are planned to 'rot' thus providing habitats that may eventually be colonised by the local wildlife.
