**DESIGN, ACCESS  
&  
HERITAGE STATEMENT**

**MARCHINGTON HALL  
MARCHINGTON  
STAFFORDSHIRE**

December 2019

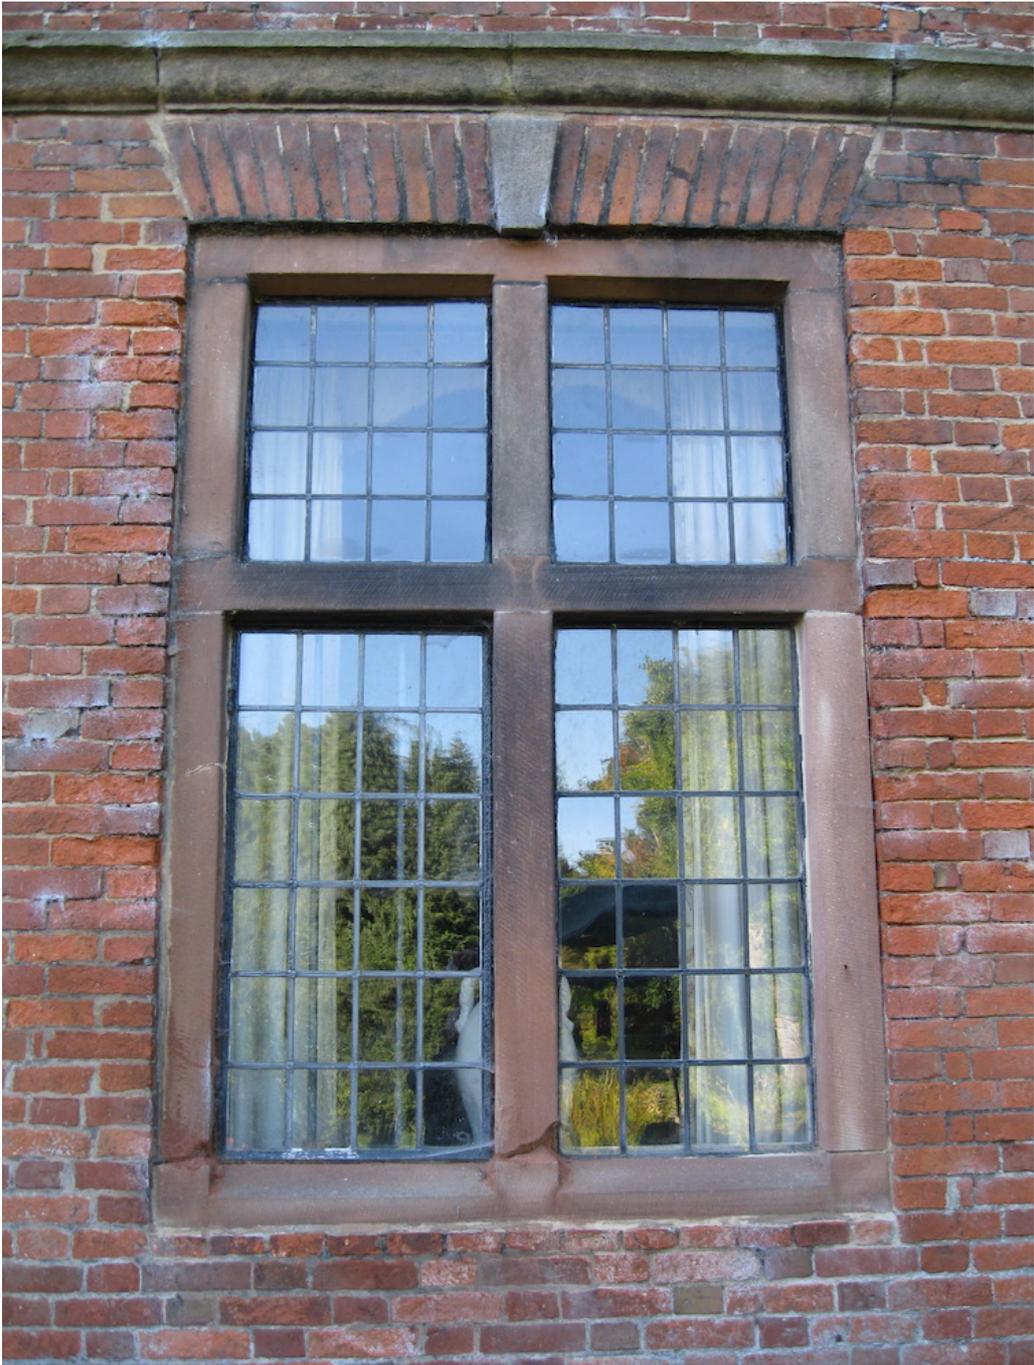
3.1 Two of the windows to the rear elevation have suffered damage over the years to the sandstone stonework forming the window surrounds, with two mullions, a transom and a stone header requiring replacement.

Ground floor window showing damage to the lower right-hand jamb and mullion

4.2 All four of the existing glazing panels to the ground floor window would be carefully removed and stored safely for re-use. The stone transom would be supported whilst the damaged jamb and mullion were removed. New stone sections would be installed and fixed securely in place. The temporary supports would be removed and the windows re-glazed with the original glazing sections.

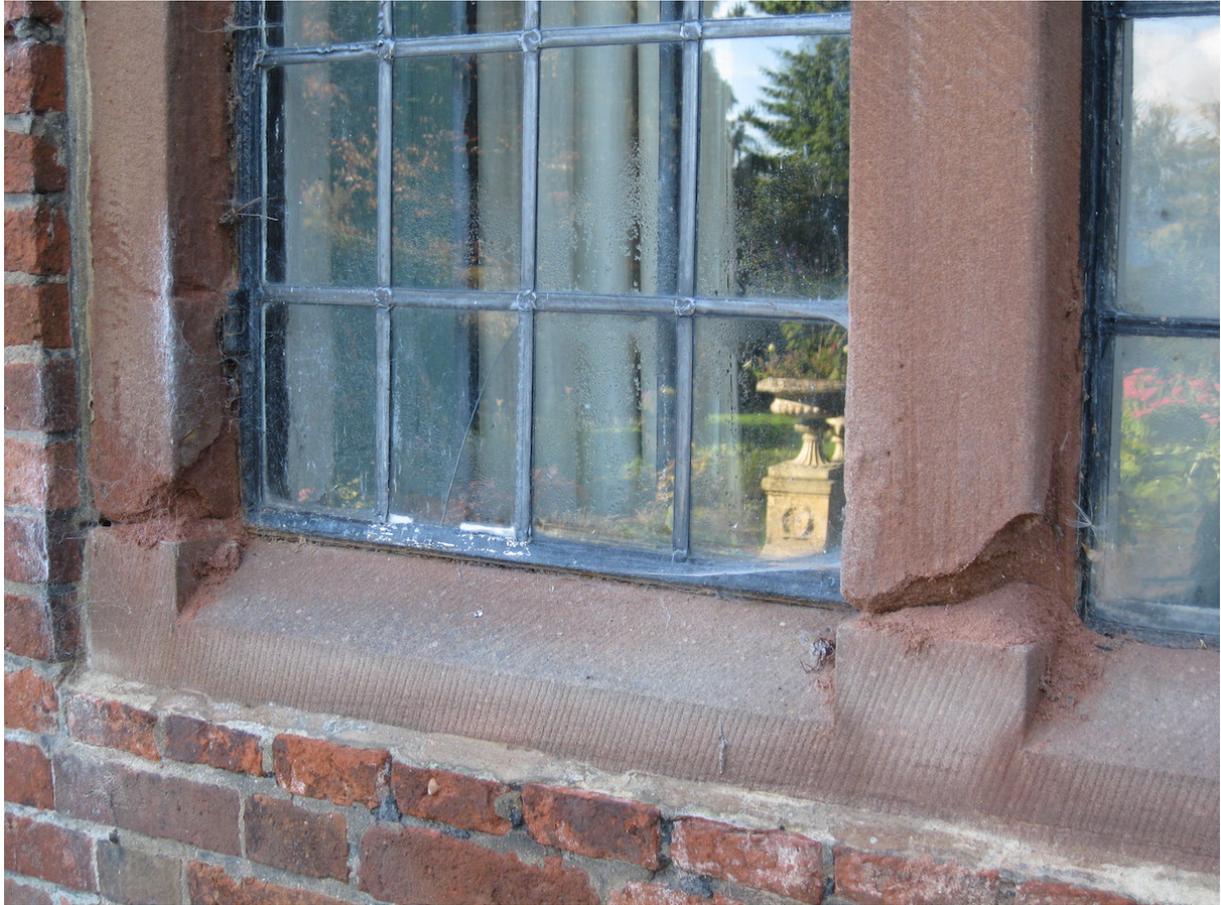
Detail of the damaged stonework

4.1 The proposed repairs to the window stonework would involve removing the damaged stone sections and replacing them with sandstone elements that match as far as possible the dimensions, colour and texture of the damaged stone.

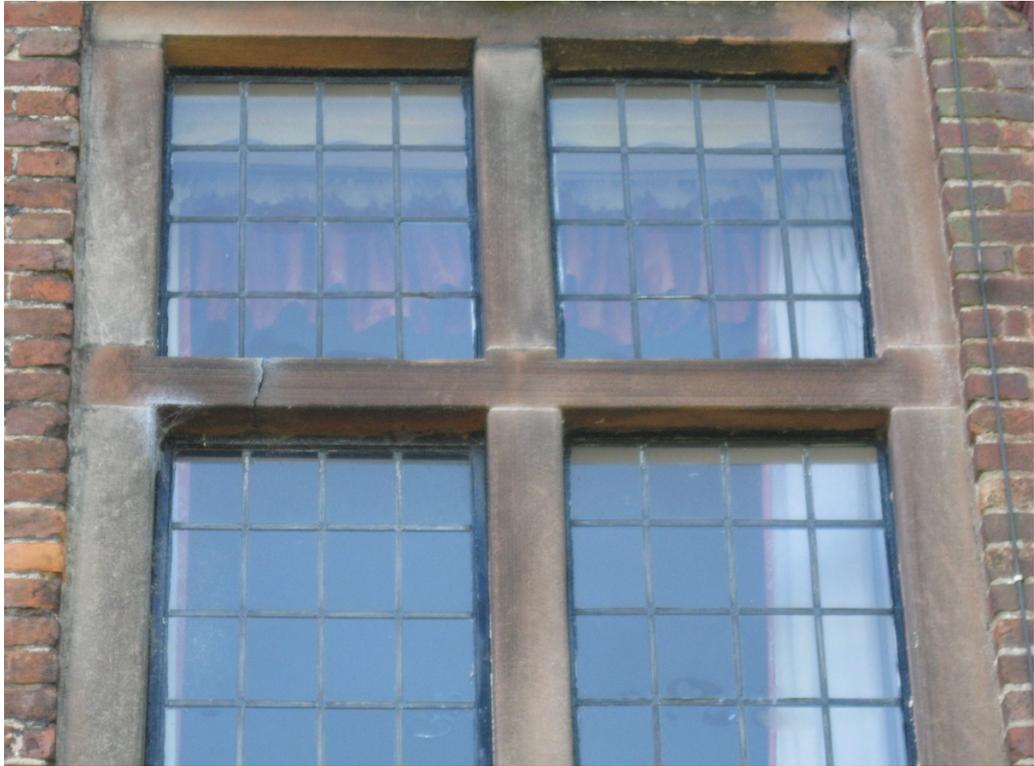
First floor window with cracked right-hand transom and left-hand of the head

4.3 The first floor window glazing would be removed as for the ground floor window. The head of the window would be supported whilst the transom and upper sections of the window stone elements were removed. New stone sections would be installed and fixed securely in place. The temporary supports would be removed and the windows re-glazed with the original glazing sections.

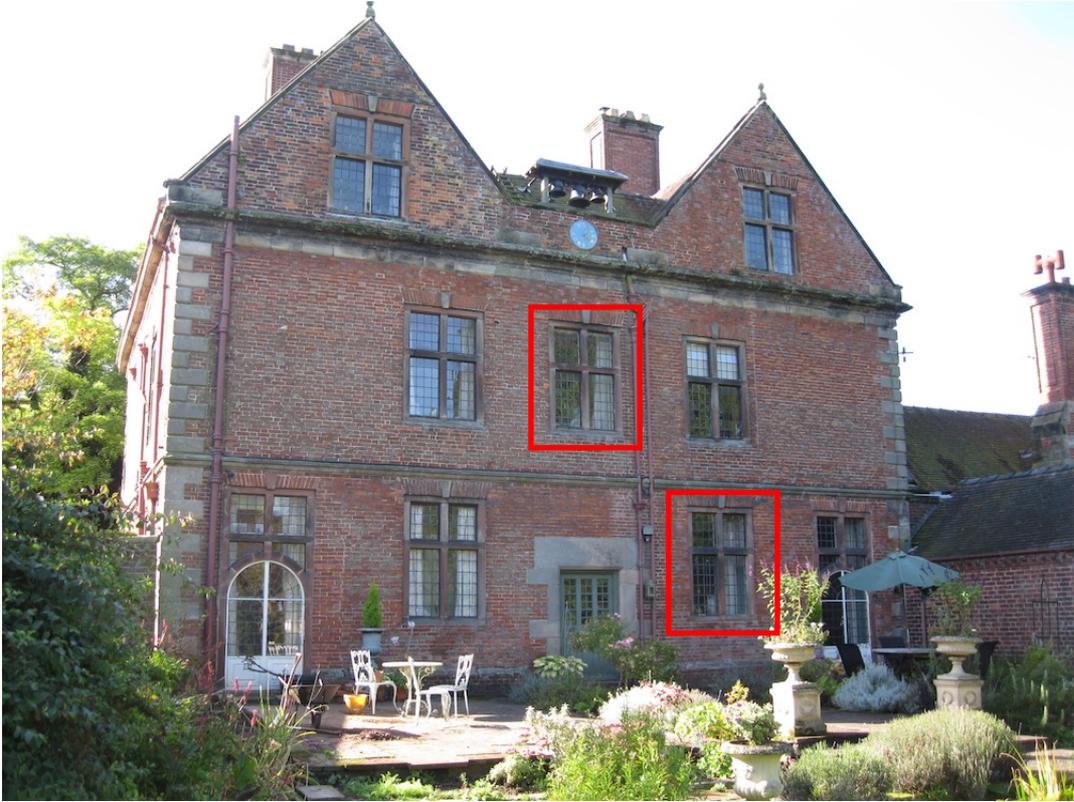
3.2 The damaged windows are highlighted below.

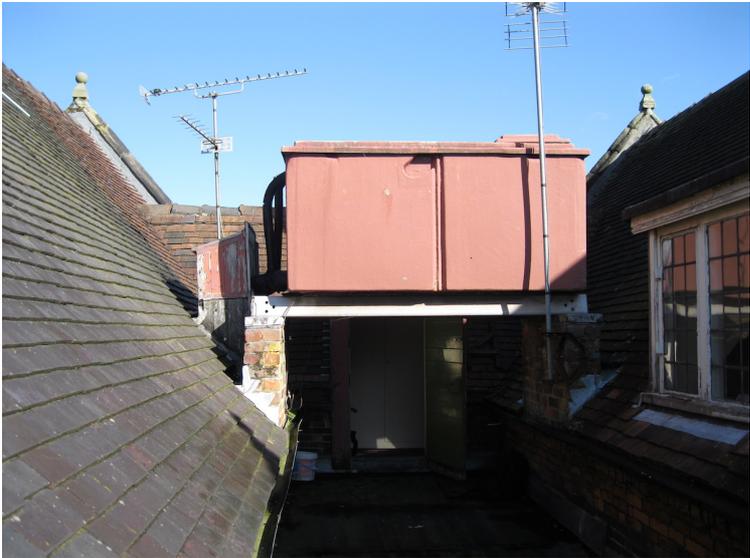
Roof-mounted water tank

3.3 The boxing protecting the water inlet pipes from the roof-mounted water tank is suffering considerable decay and is letting water in, causing damage to some internal plaster.

6.4 The water tank is not visible from the ground from any angle and the necessary replacement of the boxing will have no detrimental effect on the character of the building.

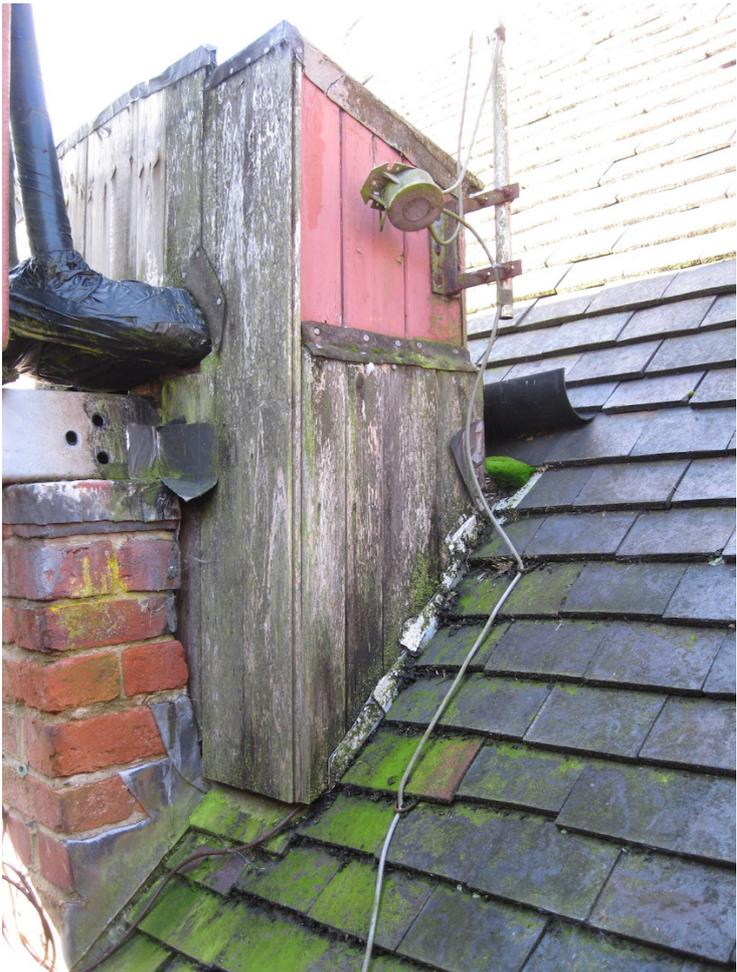
Boxing to water inlet pipework

4.4 The damaged timber enclosure to the water inlet would be replaced with a new timber enclosure with a lead valley gutter at the roof abutment. This would prevent further water damage to the internal fabric of the building.

6.3 The replacement boxing will improve significantly on the existing situation. The timber will be treated SW with a lead covered roof, rather than the existing felted roof. The existing structure does not have a valley gutter, which allows water ingress and subsequent damage to the internal fabric of the building. The proposed valley gutter will help protect the integrity of the building without detracting from the character of the building.

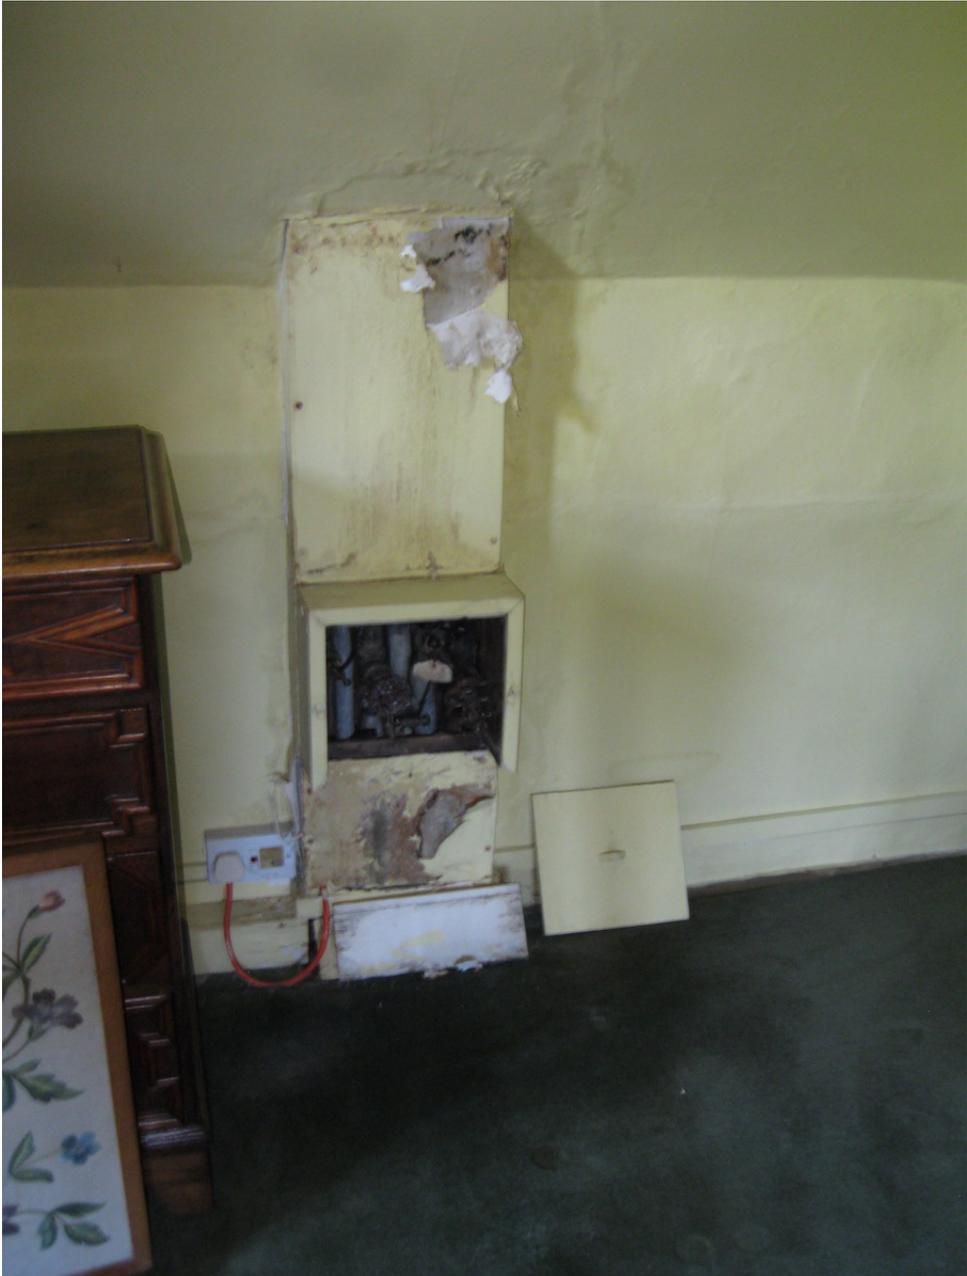
Internal damage

4.5 The damaged plaster would be carefully removed, any underlying damage to the walls repaired, and the damaged sections re-plastered with a lime plaster to match the existing.
