## **Proposed Replacement of Windows**

## 4 The Yews, Mill Street Rocester, ST14 5LZ

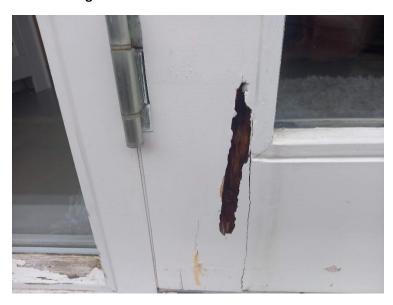
Significant Rot on the rear French doors.

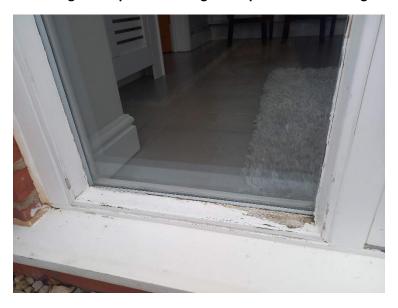
Peeling and exposed beading – damp wood and leaking

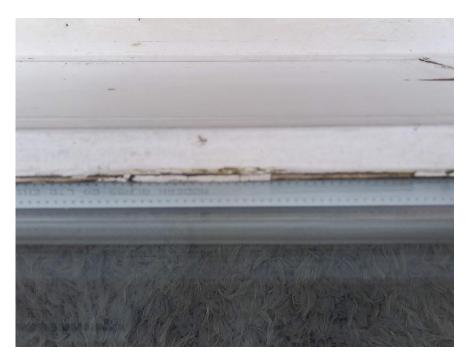
## Substandard putty used in installation now hard and cracket and leaking.

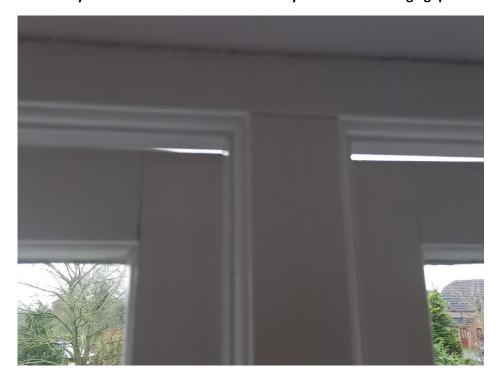
Badly manufactured casements on many windows with large gaps

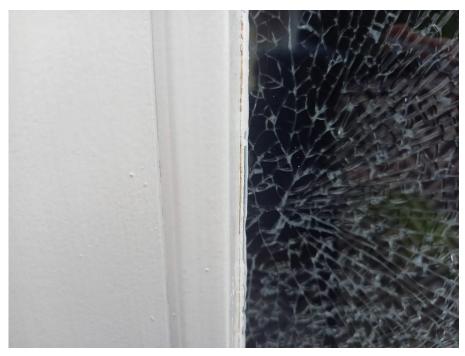
Broken window glazing units due to incorrect fitting and no expansion
