**Appraisal of Existing Condition
and
Commercial Viability for Conversion
in respect of
redundant agricultural and former kennel/cattery buildings
at
Springlands Farmhouse
Toothill Road
Uttoxeter
Staffordshire
ST14 8JU**

**Prepared by
I G Whitfield BSc(Hons)MRICS**

Date of Report: December 2010

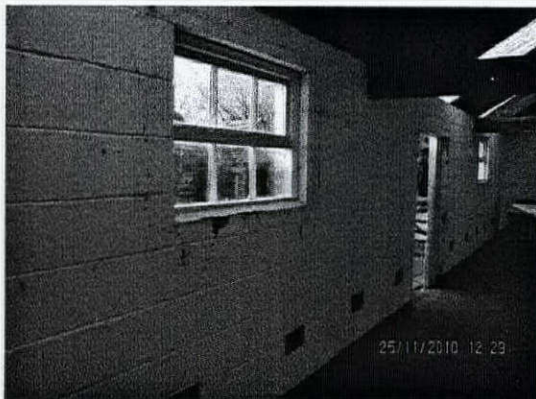
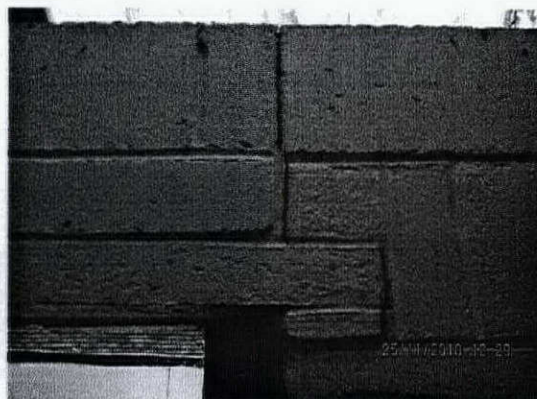
A vertical fracture of 4mm maximum width extends above the left hand doorway lintel end internally with a hairline fracture through mortar pointing externally. Hairline fractures extend beneath each window and above the right hand lintel end of the right hand window internally. This movement is not of structural significance and no remedial works are necessary.

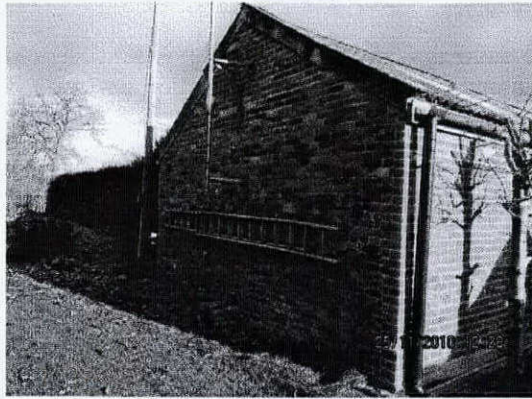
The front and gable walls are plumb and vertical to within normal construction tolerances.

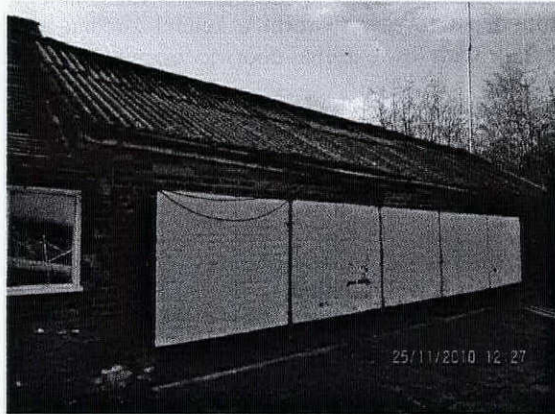
The line of the rear wall does show a curve and an inward lean at the eaves to the centre of the elevation. This coincides with truss bearings suggesting that the damage was caused by the cranking of the original roof towards the front of the building. This will have resulted in the probable outward curve of the front elevation, the principal reason for its reconstruction. Completion of the latter has stabilised the rear wall.

Mortar pointing is generally satisfactory, although making good defective mortar and weathered brickwork to the left hand gable wall will be required in conjunction with refurbishment works.

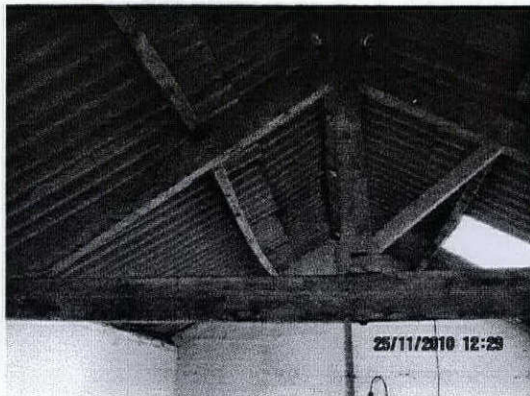
The trusses are structurally sound, albeit with localised active infestation by common furniture beetle, although a single strut has been lost with reinstatement required.

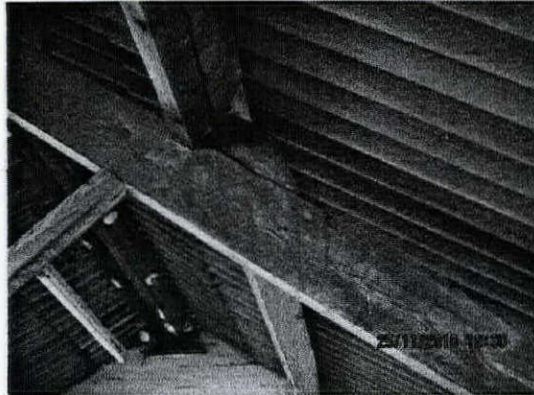
Purlins show longstanding deflection and that centre purlin at the rear a significant split which has compromised its structural integrity. The rear left hand purlin adjacent has been replaced with a reclaimed timber of smaller 150mm x 75mm dimensions.

The present lightweight roof covering is adequately supported despite these defects. Nevertheless, it is anticipated that provision of a traditional tiled roof covering will demand replacement of the purlins and the raising of the truss bases to create improved headroom.

The roof timbers have suffered some damage and are partially under-sized. It is expected that conversion works will demand renewal of trusses and purlins, not least to permit improved headroom, but also to ensure current suitability for conventional roof tiling in replacement of the current lightweight asbestos cement cladding.

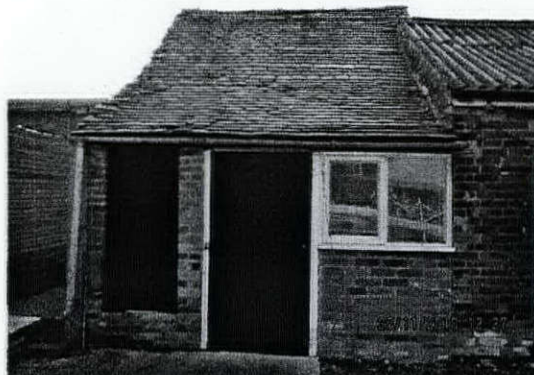
The rear elevation is of 225mm brick construction with two door and window openings. The brick panel to the underside of the modern window has been rebuilt in reclaimed brickwork. An original 225mm brick pier lies between the doorway openings.

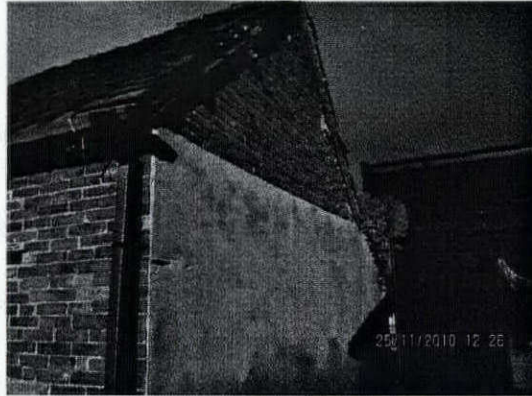
The gable wall has exposed original 110mm half brickwork to the apex. This shows a slight outward lean, although not sufficient to threaten structural stability. The brickwork is in need of repointing and the cutting out and replacement of weathered bricks. The main lower section of the wall has a modern render finish which is undecorated. It is in sound condition, although in contact with underlying concrete and damp affected at the base.

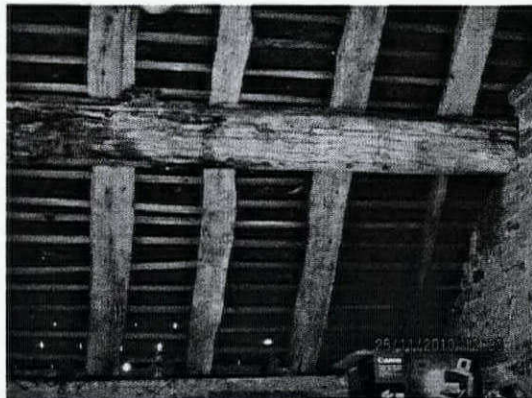
- 3.2.4 The roof of the end-bay is of single timber purlin construction, the rear purlins approximately 200mm x 150mm and the front approximately 175mm square with chamfered edges. The rafters are typically 150mm laid flat with sawn timber battens supporting plain clay tiles. The rafter feet bear on large 100mm deep timber wall plates.

The purlins and rafters are affected by active beetle infestation and the exposed purlin ends by wet rot. Conversion and refurbishment of the building may be expected to demand replacement of the roof timbers. Nail fixings of timber battens have corroded giving rise to evidence of slippage, particularly to the verges and eaves, and at the rear. A cement fillet provided at the junction of the main building has deteriorated, giving rise to consequent penetrating dampness in the rear storage room.

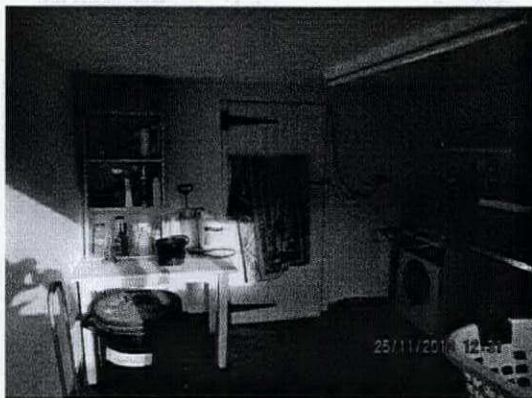
Internal walls of the kennel kitchen have plasterboard dry lining internally, the plaster having deteriorated as a result of rising dampness. The walls are plumb and vertical.

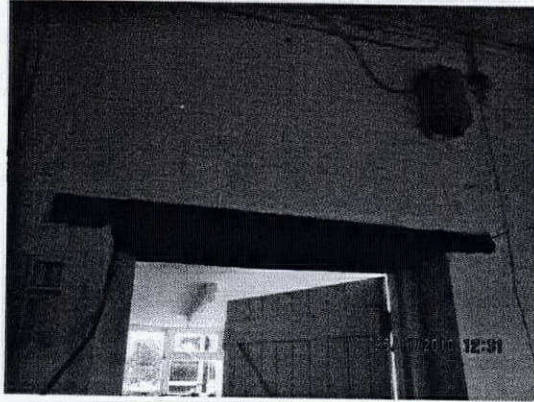
The 225mm brick wall leading to the rear compartment has a timber lintel above the doorway opening laid flat. There is a stepped hairline fracture above the door, although of no structural significance and the masonry remains sound. The walls of this compartment are of painted brickwork. The concrete floor is at the same level as the adjacent described above.

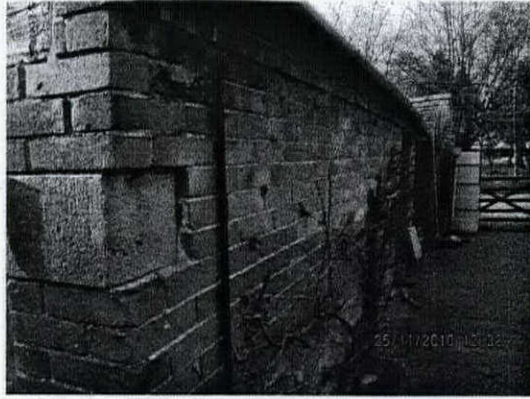
- 4.2.1 The front (north) elevation has projecting eaves course and single doorway opening with parallel timber lintels spanning between inset brick piers. Original sandstone blocks are retained to the doorway opening.

The elevation has suffered outward movement arising from roof-spread. Whilst plumb and vertical to within normal construction tolerances at the corners of the building, reconstruction of the remainder of the elevation is advisable, unless it can be buttressed satisfactorily by the proposed link between the buildings.

North-facing wall: Take down and rebuild wall plumb and vertical between retained corner brickwork. It is anticipated that the roof will be renewed and re-aligned to intersect the front elevation wall.

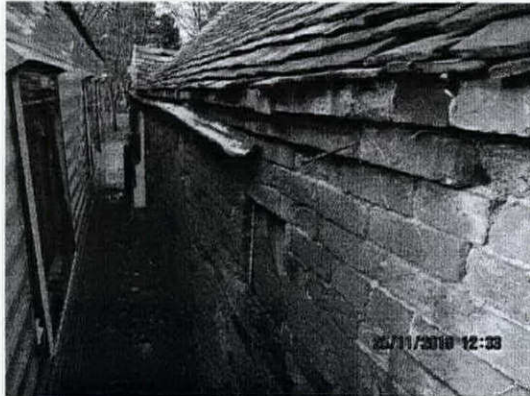
- 4.2.2 The rear elevation has a single doorway opening with timber lintel support and projecting brick course to the eaves. Lower ground levels reveal a projecting brick corbel at the base.

The elevation is plumb and vertical and there are no indications of structural movement. Mortar pointing is in very poor condition and brickwork has been weathered badly as a result of this exposure to prevailing weather conditions (prior to stationing of static caravan). This has been exacerbated by spillage from defective guttering. The complete repointing of the elevation and the repair of badly weathered brickwork is required.

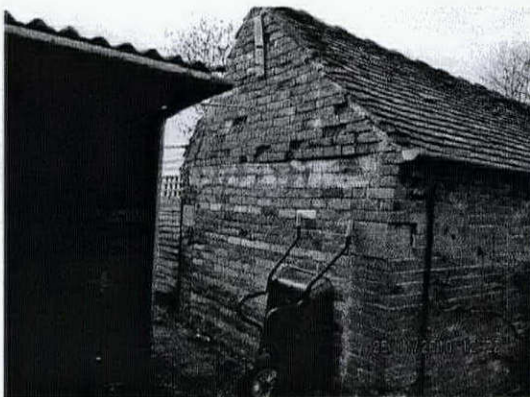
- 4.2.3 The left-hand gable wall has original 110mm half brick panel to the apex, overlying a timber lintel above a former full width opening. The opening has been infilled with 225mm solid brickwork.

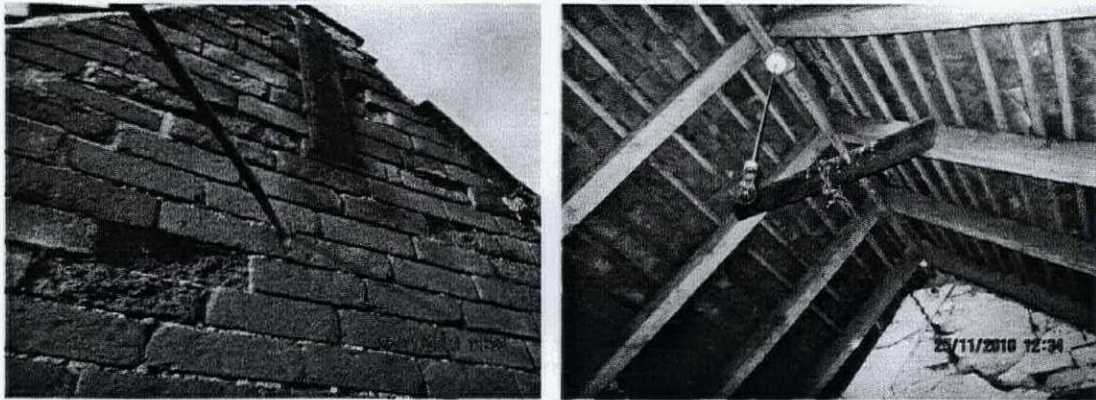
The gable apex has suffered outward movement and a steel patten plate restraint has been applied with rudimentary wire fixing to a short timber spanning between facing rafters.

East-facing gable wall: Reconstruct gable apex wall plumb and vertical in minimum 225mm solid brickwork and remove sandwiched timber lintel.

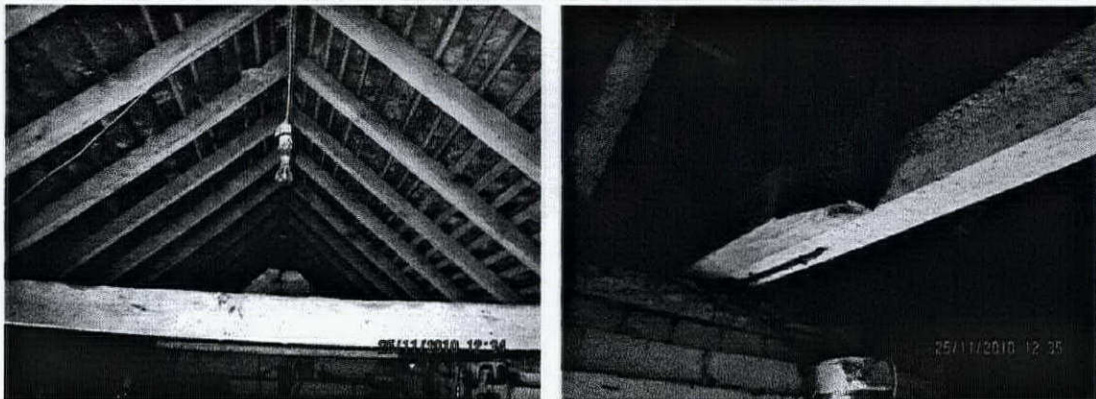
The roof is of 75mm square common rafter construction, spanning to 75mm square wall plates at the base. There is a high level ridge board and a mixture of modern tanilised and older slender softwood tile battens. The roof is restrained by two 100mm x 75mm collars which have been extended by infill sections following roof-spread.

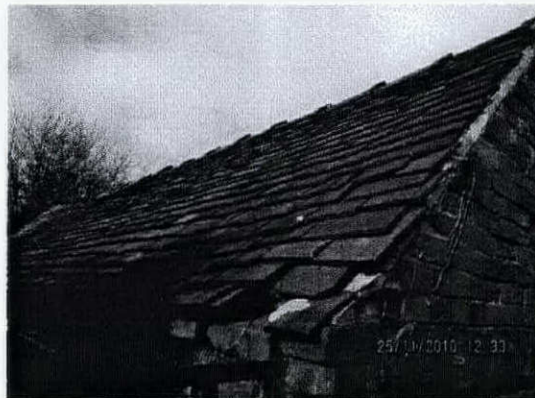
The Staffordshire blue clay tiles have suffered general slippage, particularly to the rear elevation.

It is anticipated that refurbishment and conversion works will extend to the stripping and replacement of the roof structure and covering, dependent upon the precise nature of works undertaken to the front elevation.

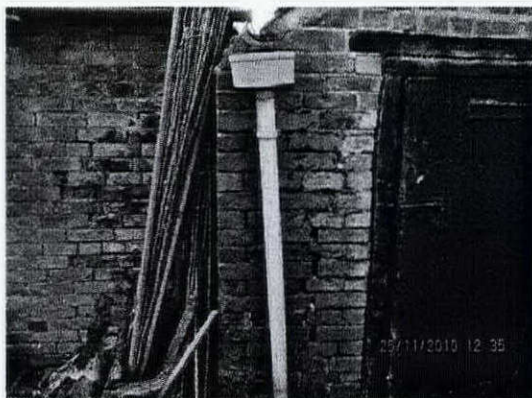
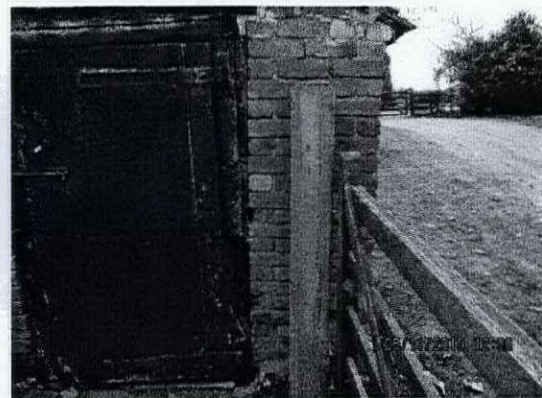
- 5.2.1 The front gable wall has timber lintel overlying the doorway opening with reconstructed reclaimed brick panel above. Brickwork to the left hand side of the doorway opening has been affected by longstanding penetrating dampness with cutting out and replacement of brickwork at the corner of the building required in order to ensure its future stability. The elevation and the panel to the right hand side of the front wall has suffered outward movement which suggests the foundations to be inadequate. Whilst there are no suggestions of continuing movement, it is recommended that this panel of brickwork be replaced in conjunction with other work to the front gable noted.

North facing gable wall: Take down and rebuild plumb and vertical between and to include corner return walls.

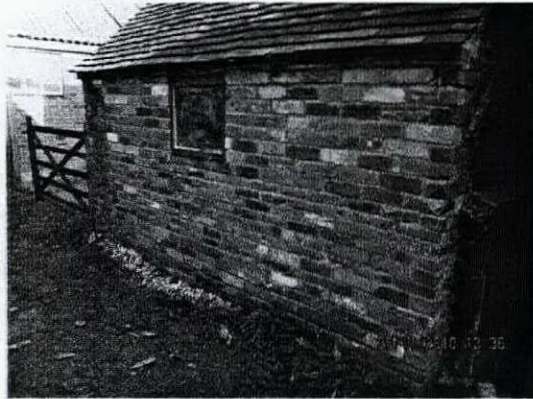
- 5.2.2 The right hand elevation has been reconstructed in reclaimed brickwork in recent years.

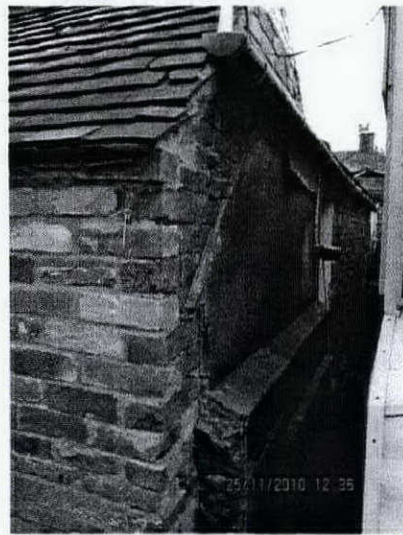
5.2.3 The rear gable wall is plumb and vertical with no indications of structural movement.

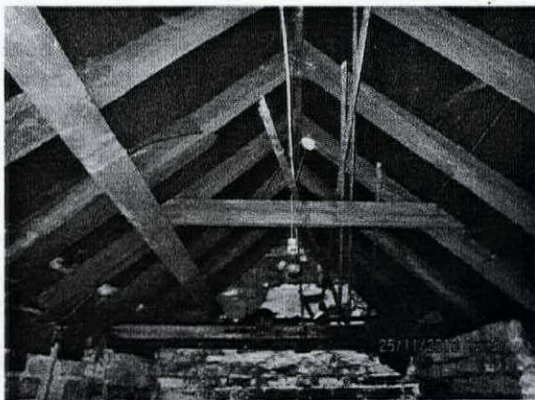
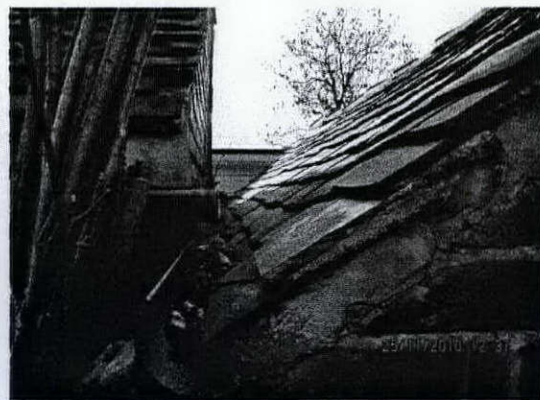
5.2.4 The roof is in sound structural condition, albeit that replacement is anticipated in conjunction with conversion and refurbishment works. There is evidence of penetrating dampness through the lead roof valley and the stripping and re-roofing of this section is required.
