## Asbestos Re-Inspection Survey for

CEVA Logistics

Shed 1 Ceva Logistics  
B&Q Distribution Ct  
Burton Road, Burton Upon Trent  
DE14 3EG  
(Asbestos Management 2012)

Project Number: 20461/12KB

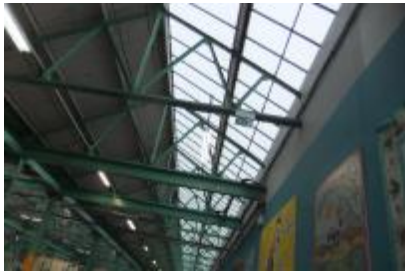
Location ID: 4513 Location Ref: Sample 2 Product Type: Ropes and woven textiles

Area/ Floor/ Room/ Product: Ceva Shed 1: General through out: Warehouse: Skylight

Material Comments:  
A photographic reference was made to the roof skylights within Shed 1, presumed to contain asbestos products, i.e gaskets and seals. Skylights still in place during management visit 31/01/2012. Please note vented roof outlets may also contain asbestos.

Damage: No visible damage

Material Risk Score: 4 Material Risk Band: Very Low Risk Priority Risk Score: N/A

Action:  
Do Not Disturb - Contractors to be Aware

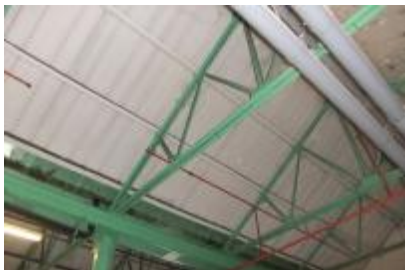
Location ID: 4514 Location Ref: Sample 3 Product Type: Asbestos cement

Area/ Floor/ Room/ Product: Ceva Shed 1: Roof level: Warehouse: Roofing Sheets

Material Comments:  
A photographic reference was made to the roofing sheets internally within Shed 1 warehouse previously identified as containing asbestos products. Noted 31.1.2012.

Damage: Good condition

Material Risk Score: 3 Material Risk Band: Very Low Risk Priority Risk Score: N/A

Action:  
Do Not Disturb - Contractors to be Aware

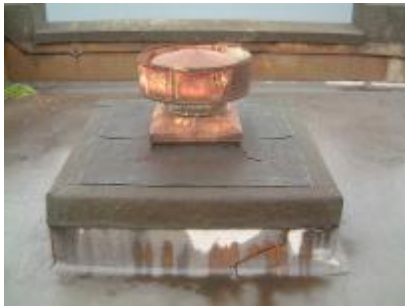
Location Ref: Sample 6

Area/ Floor/ Room/ Product: Ceva Shed 1: Roof level: External: Vent Outlet

Damage: No visible damage

A photographic reference was made to the vented outlets at roof level, presumed to contain asbestos products, i.e gaskets and seals. Still in place during management visit 31/01/2012.

Material Risk Score: 4

Do Not Disturb - Contractors to be Aware

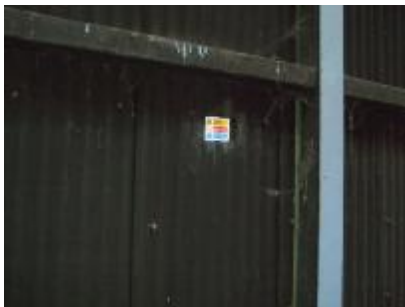
Location Ref: Sample 8

Area/ Floor/ Room/ Product: Ceva Shed 1: Ground floor: Warehouse: Felt / Bitumen

Damage: Low damage

A photographic reference was made to the felt bitumen coverings within the canopy shelter of Shed 1 identified as asbestos products still in place during management visit 31/01/2012.

Material Risk Score: 3

Warning Labels Applied. Do Not Disturb

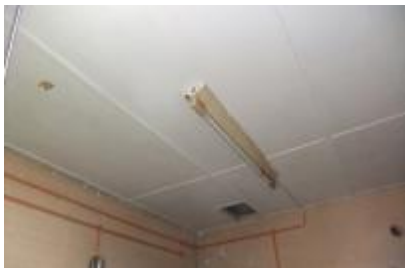
Location Ref: Sample 11

Area/ Floor/ Room/ Product: Ceva Shed 1: Ground floor: Electrical Room: Board

Damage: High damage

A photographic reference was made to the asbestos board within the electrical stores to the front of Shed 1. Board is in very poor condition and requires removal by licensed contractors and the electrical stores environmentally cleaned.

Asbestos Type: Amosite & Chrysotile

Quantity: 60m<sup>2</sup> Approx

Material Risk Score: 9

Warning Labels Applied. Do Not Disturb
