APPENDIX F1

Flood Risk Assessment (February 2010)

National Football Centre Hotel & Sports Facilities, St. George's Park Flood Risk Assessment

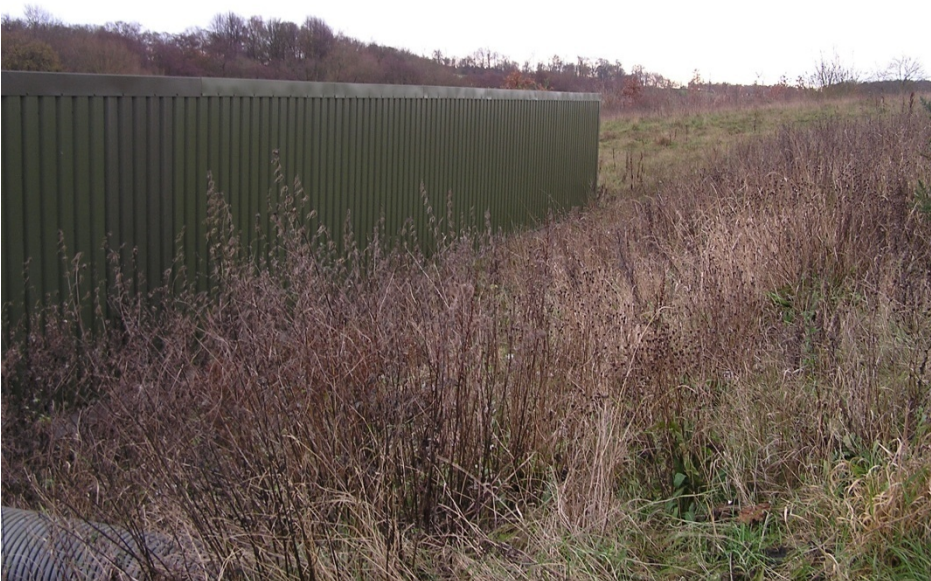
Drainage from and irrigation of the grass pitches is provided by the 3,000m³ storage tank located towards the south eastern edge of the wider NFC site. The overflow route from the storage tank is to the Lin Brook via a 300mm diameter pipe. Despite the unrestricted nature of the overflow system, there are no known flooding problems at the Lin Brook or elsewhere at the wider NFC site arising from the drainage of the football pitches.

Photograph 8: The 3,000 m³ drainage/irrigation storage tank

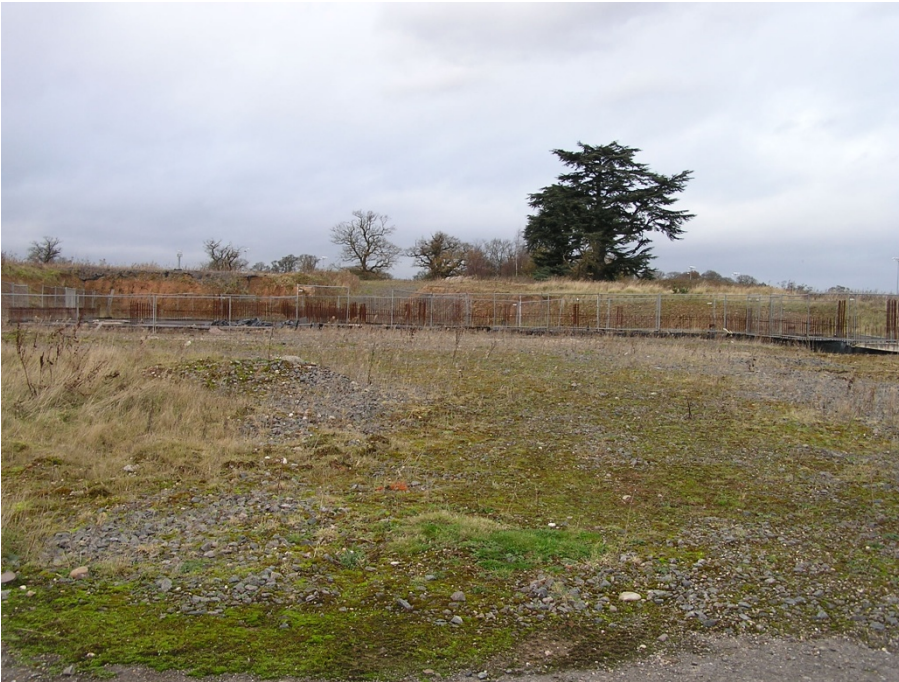
In 2001 planning permission was granted by East Staffordshire Borough Council for the NFC. The planning permission has been implemented, although not completed. On the wider NFC site at present are nine grass pitches (two of which are double sized), two synthetic pitches, an energy centre (maintenance building), and three 'dirty' seminar rooms (to provide accommodation for half-time discussion and toilets). Some associated infrastructure (including three small car parks) and drainage works have also been carried out. Moreover there is a 'vortex' control unit that controls water run-off from the pitches, via a large (3,000m³) storage tank which also serves to feed the irrigation system. Foundations were also laid for the extant hotel scheme and an underground tunnel was built with the intention of providing secure access from the hotel to the indoor pitch. Current plans for the hotel will utilise a different location from the original foundations. The foundations and underground tunnel will therefore be redundant. Please refer to Photographs 6-9.

Photograph 9: BDP design hotel foundations (now redundant)

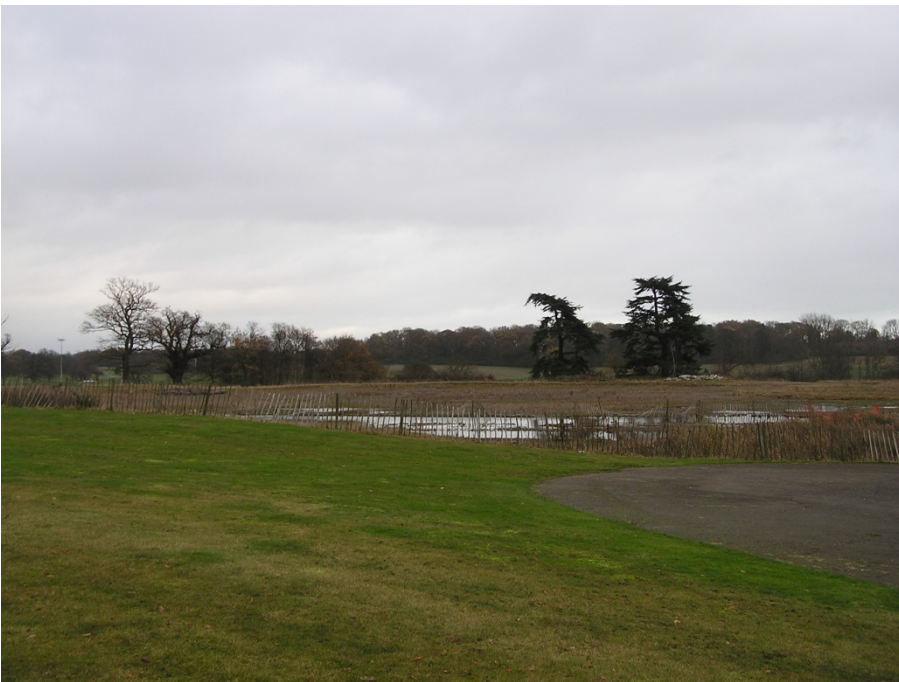
For safety purposes the underground tunnel was filled with gravel and there is presently standing water over this tunnel (Photograph 10). The site is currently used by local football teams and an area towards the north has also been let for grazing.

Photograph 10: The tunnel designed to provide access from the hotel to the indoor pitch lies beneath the water in the picture. The tunnel has been filled with gravel.

It is understood that the buried tunnel, which was designed to provide access to the indoor pitch from the extant hotel scheme, is not part of the current plans for the development. Regardless of whether this tunnel is removed (and the hole backfilled) or left in its current state, the standing water in this area is unlikely to cause any flooding problems. Furthermore this water is likely to evaporate or infiltrate during the summer months.

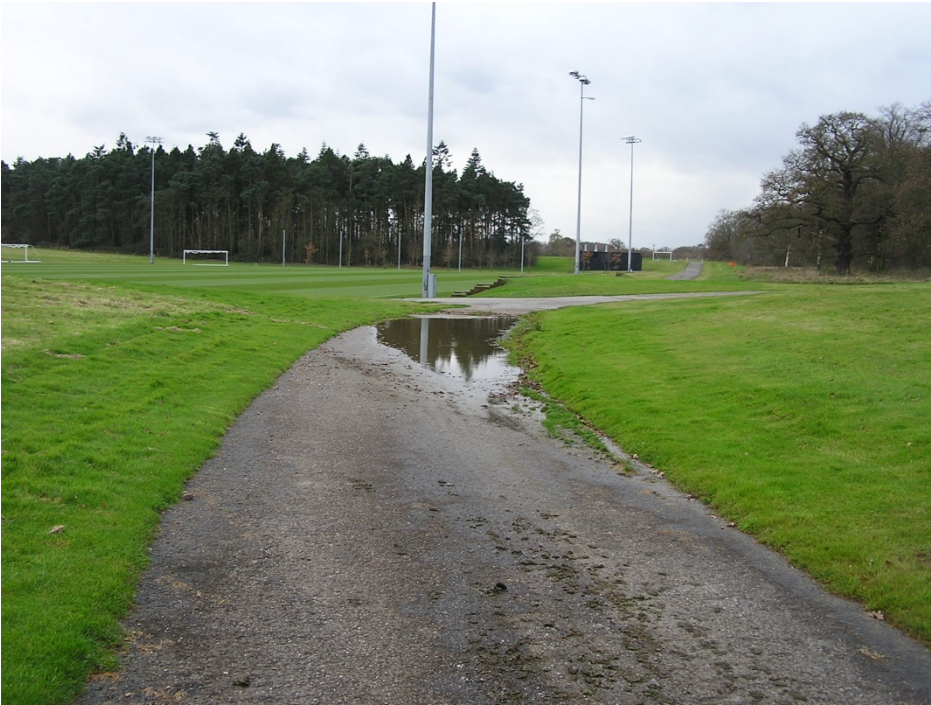
Additionally we have liaised with the groundsman at the NFC, who has confirmed that only minor ponding has occurred during the past five years since construction ceased. This ponding has occurred briefly during periods of heavy rainfall at one of the unfinished access roads. Standing water was noted at the time of the site visit (see Photograph 11). It is envisaged that this minor case of flooding will be resolved once construction resumes and the road is completed.

Ponding is known to occur in a small area along one of the unfinished access roads however; following liaison with the groundsman at the NFC it is understood that this problem is relatively minor and short lived. There is standing water over the buried tunnel which was designed to provide access to the indoor pitch from the extant hotel scheme. Whilst the depth of this water is yet to be determined it is envisaged that it is relatively shallow.

Photograph 11: Minor ponding on an unfinished access road

It is predicted that the ponding that is known to occur in a small area along one of the unfinished access roads will be resolved through the completion of the road, and the construction of roadside swales.

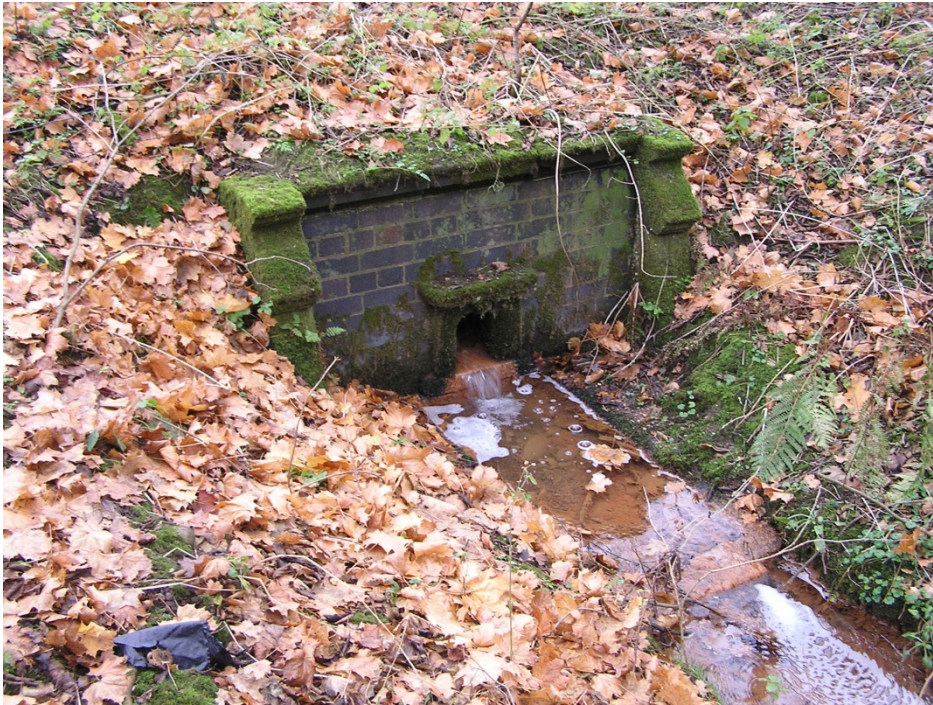
The ground investigation confirmed that an extensive network of shallow land drains has been installed at the site, discharging to the Lin Brook (see Photograph 13).

Photograph 13: Land drainage outfall to Lin Brook
