**The National Football
Centre**

Geo-Environmental Desk
Study Report

February 2010

Job number 209289-00

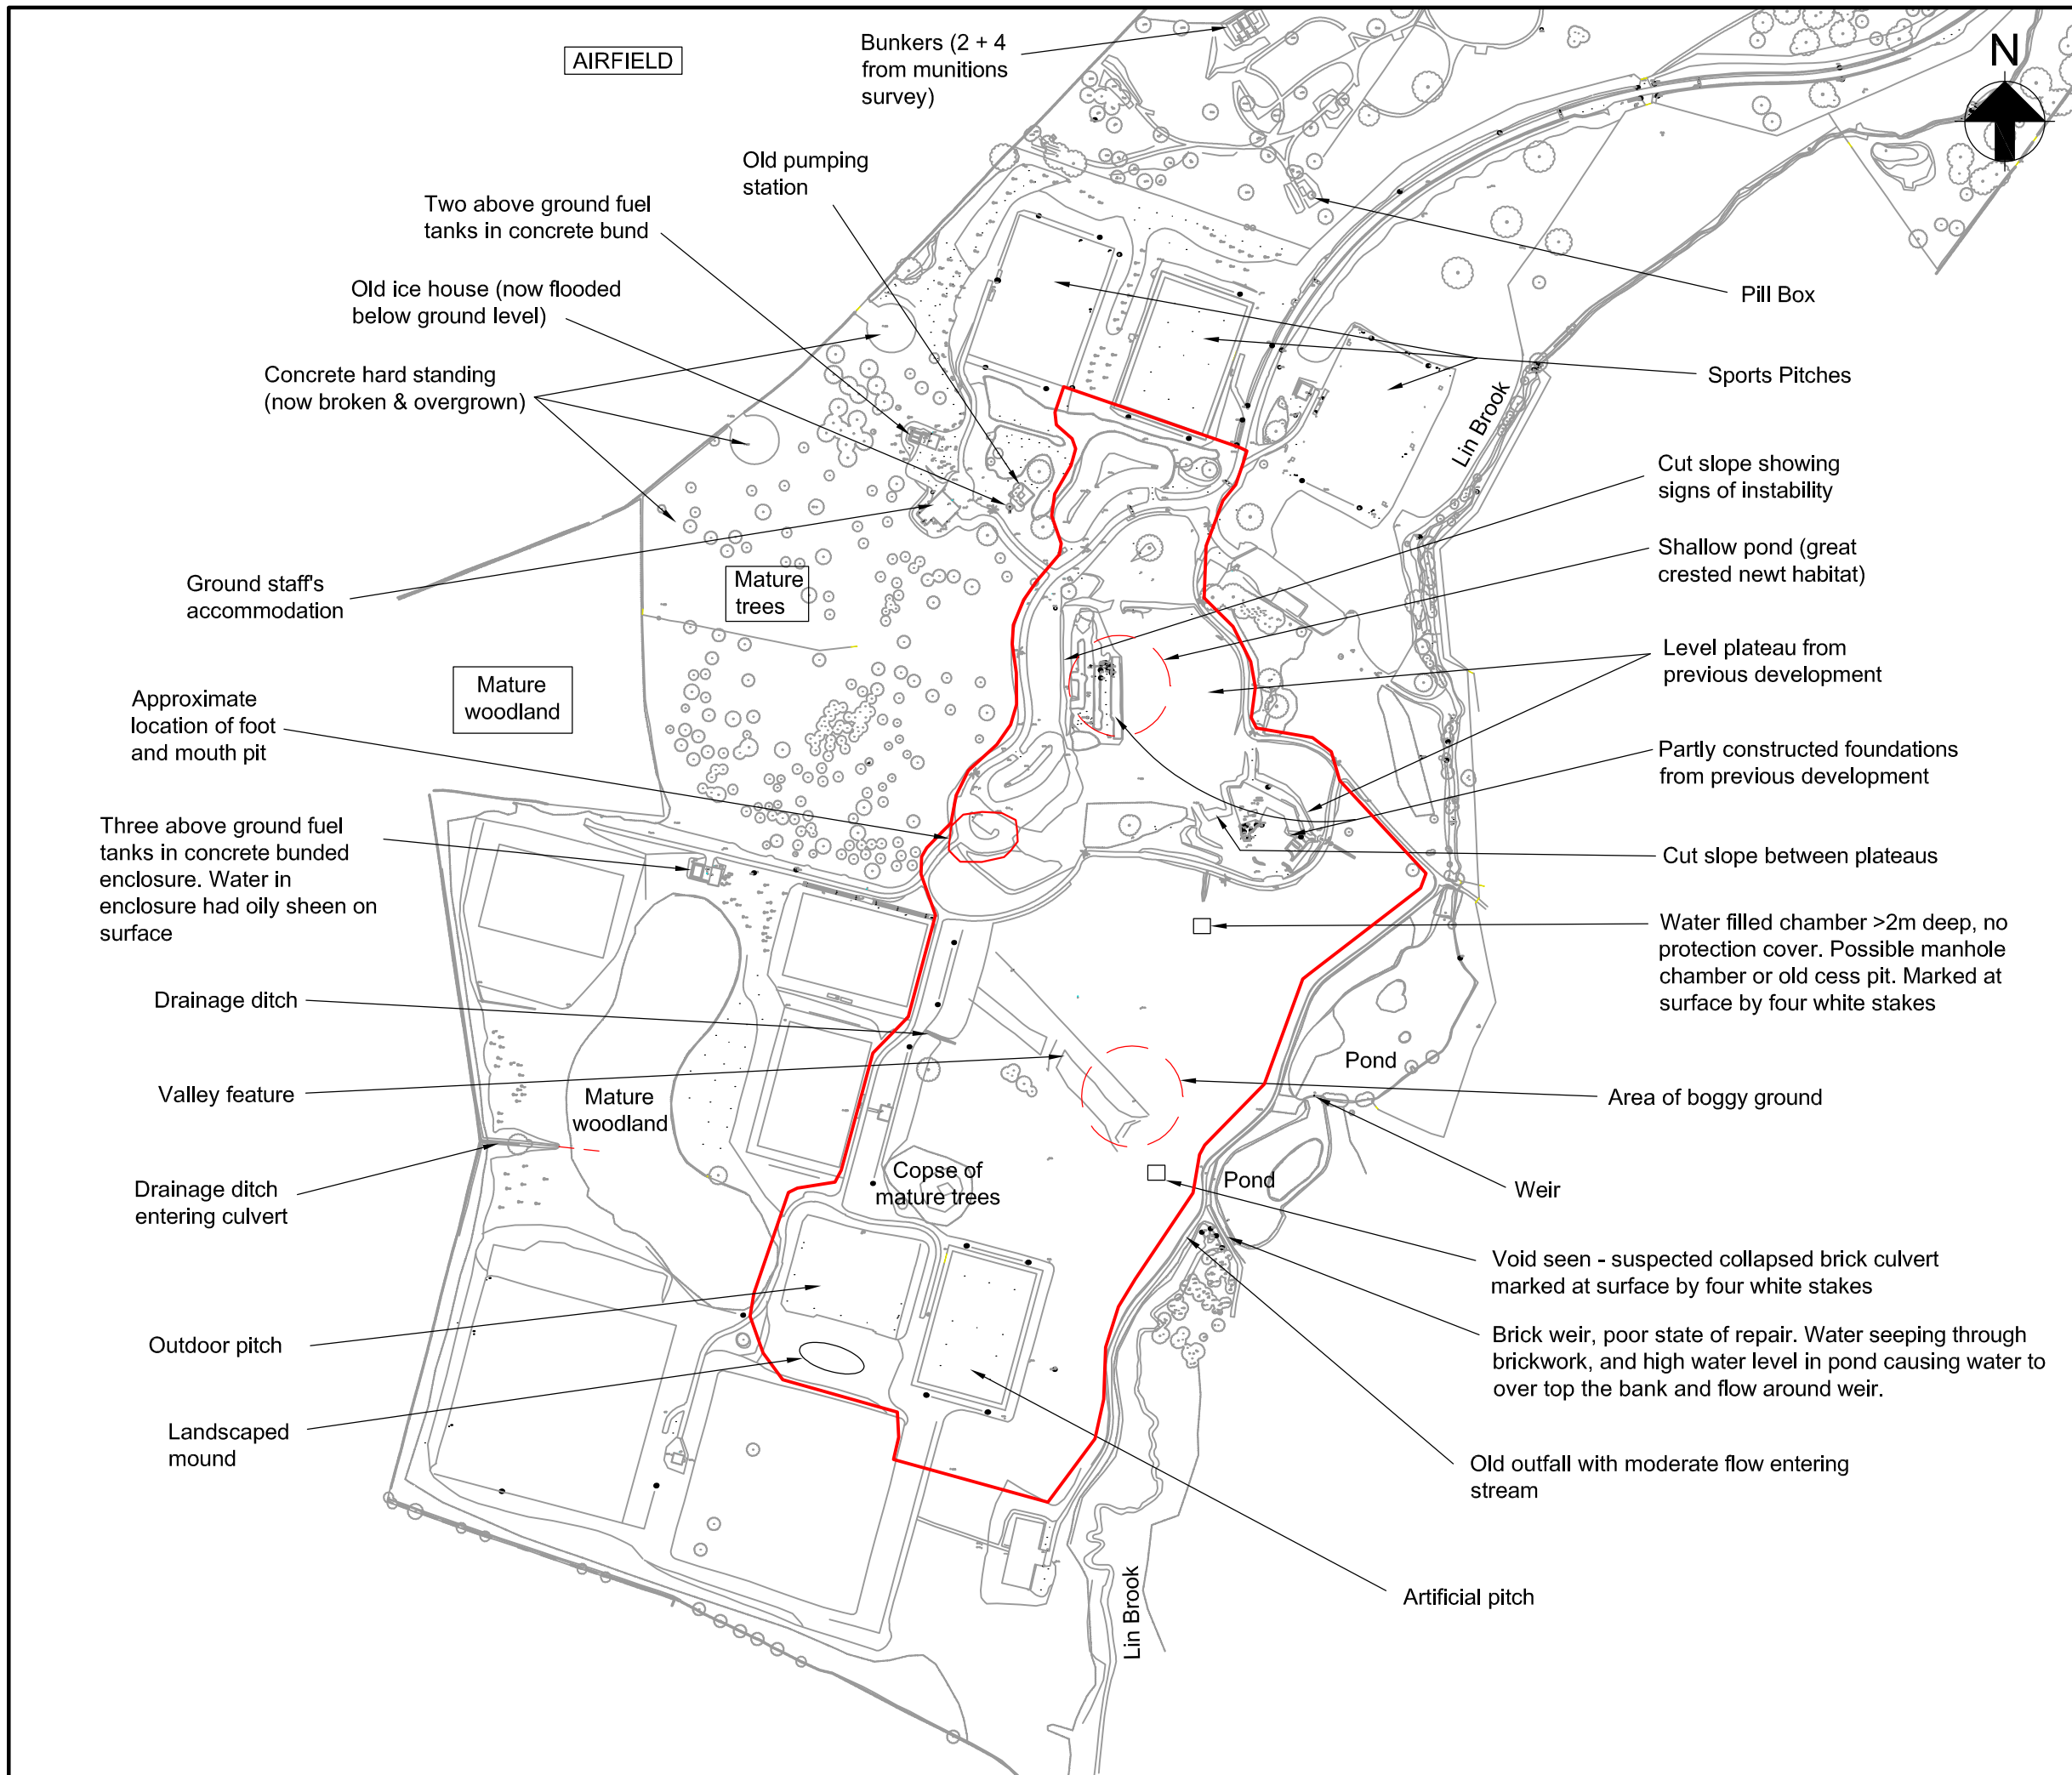
FIGURE 3

Site walkovers were carried out in November 2009 and January 2010. Features noted during the site walkover survey are annotated on Figure 3. A selection of photographs taken during the site walkover showing general views of the site are included in Appendix A. At the time of the walkover the site was predominantly covered with rough grassland sloping down to the east. An access road crossed the northern and western part of the site.

- Earthworks have been undertaken on the site as part of the 2002 previous development. This included the partial infilling of a valley in the centre of the site. This was in the area of the valley feature and boggy ground noted on Figure 3.

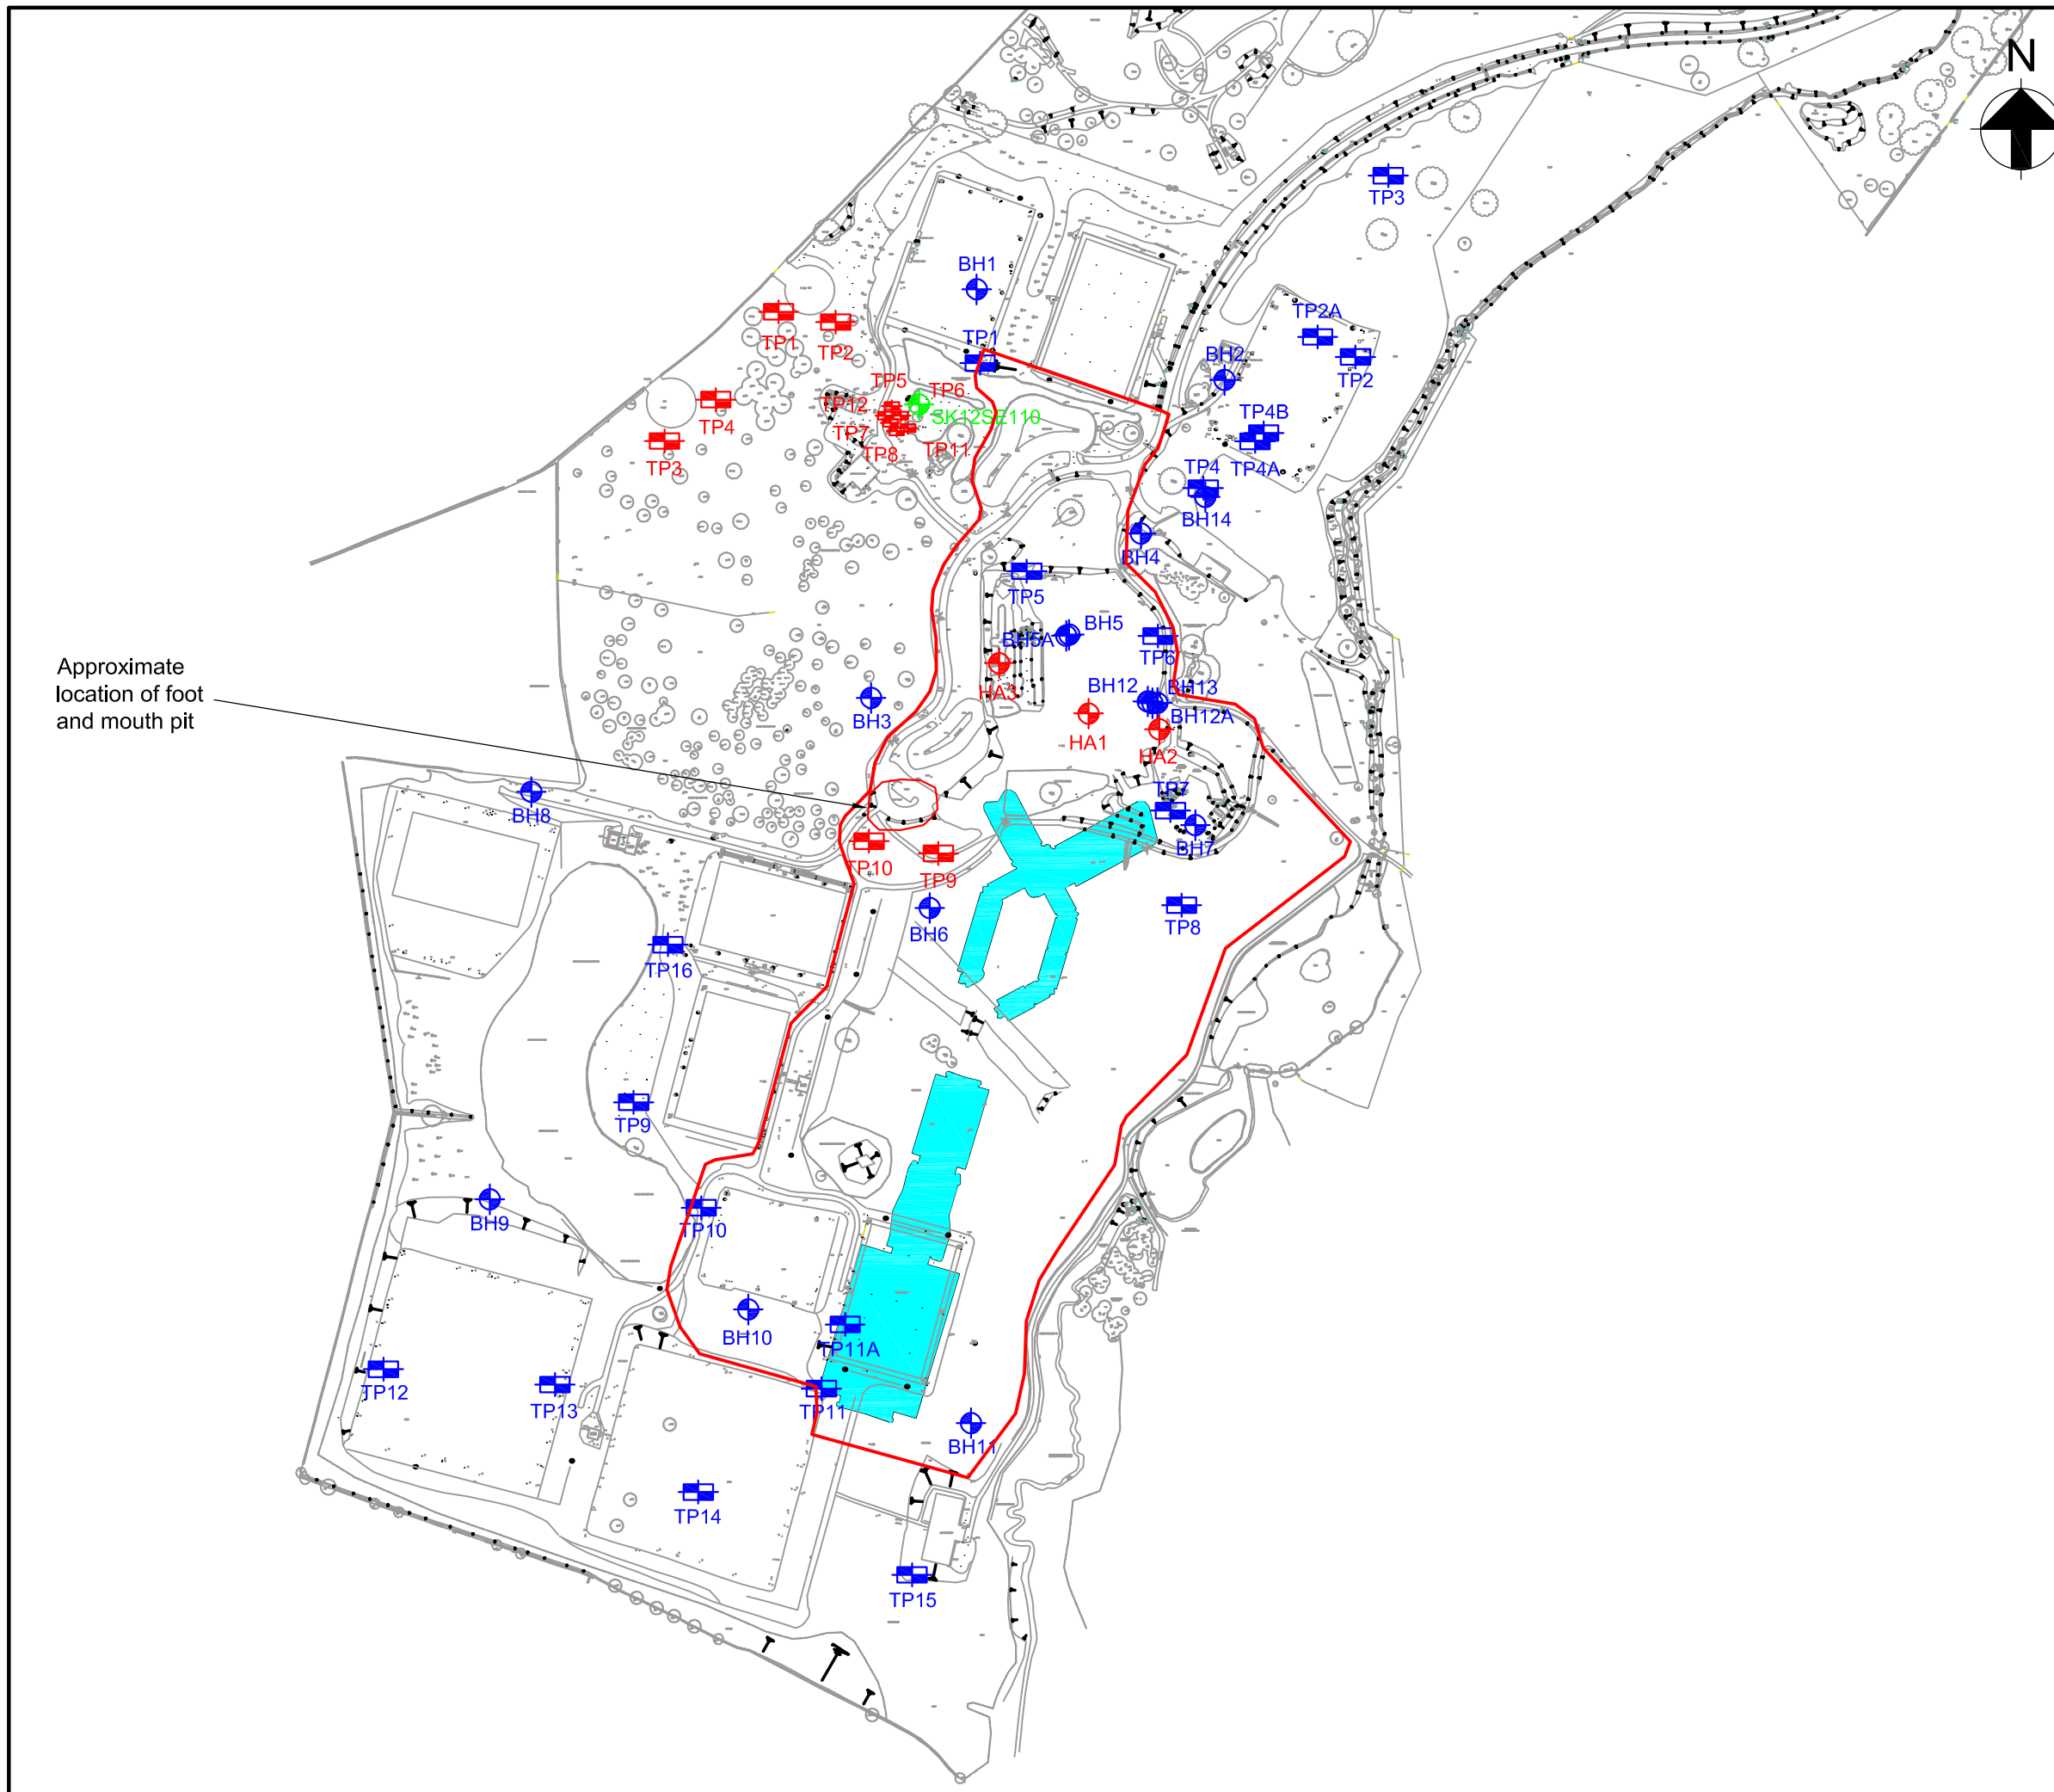
- A burial pit for animals infected with Foot and Mouth disease is present beneath the western part of the site. The pit dates to an outbreak in 1967-8, when a total of 733 animals comprising cattle, sheep and pigs were buried. It is understood that the pit was covered with lime. The approximate location of the pit is shown on Figures 3 and 4.

Approximate location of foot and mouth pit

Foot and mouth burial pit is not specifically shown

* It is recommended that the risk assessment is reviewed once specialist advice has been obtained on the risk posed by the foot and mouth burial pit.

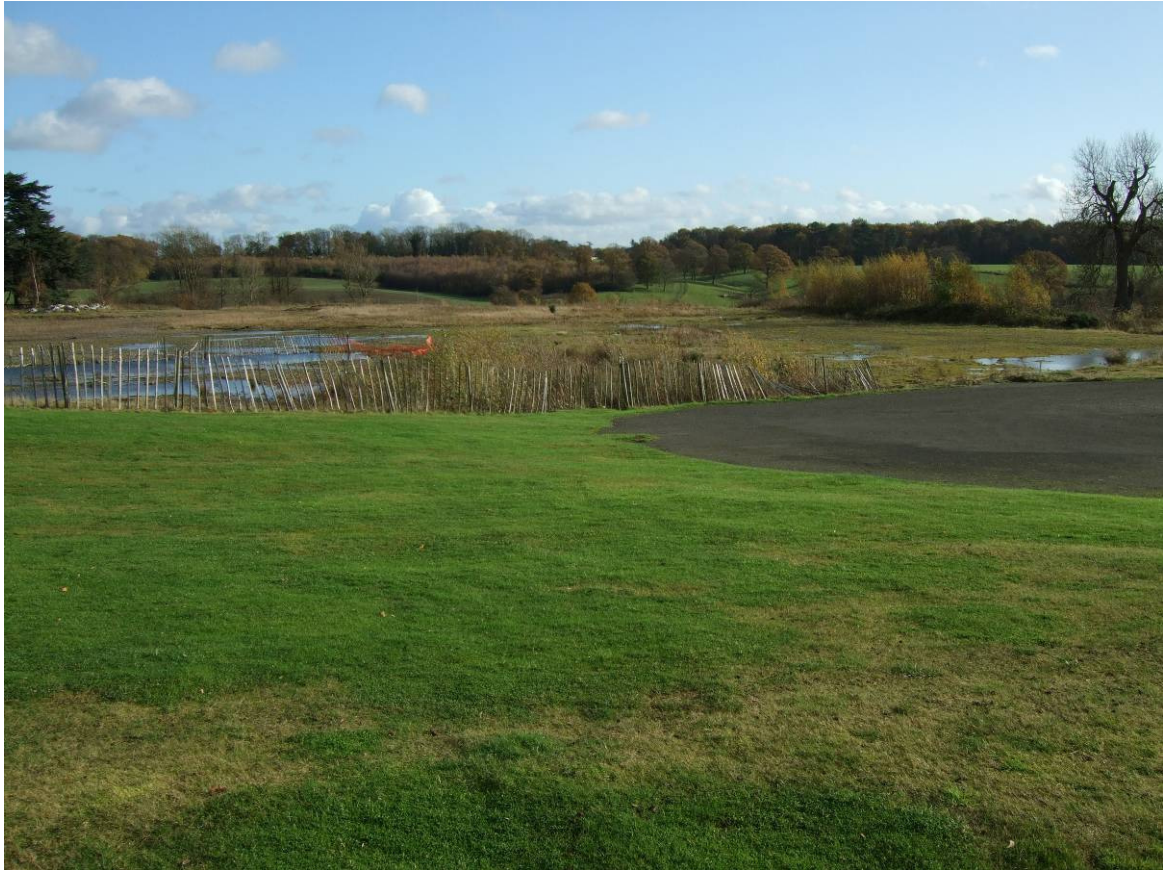
Photograph 1 Panorama from north west corner

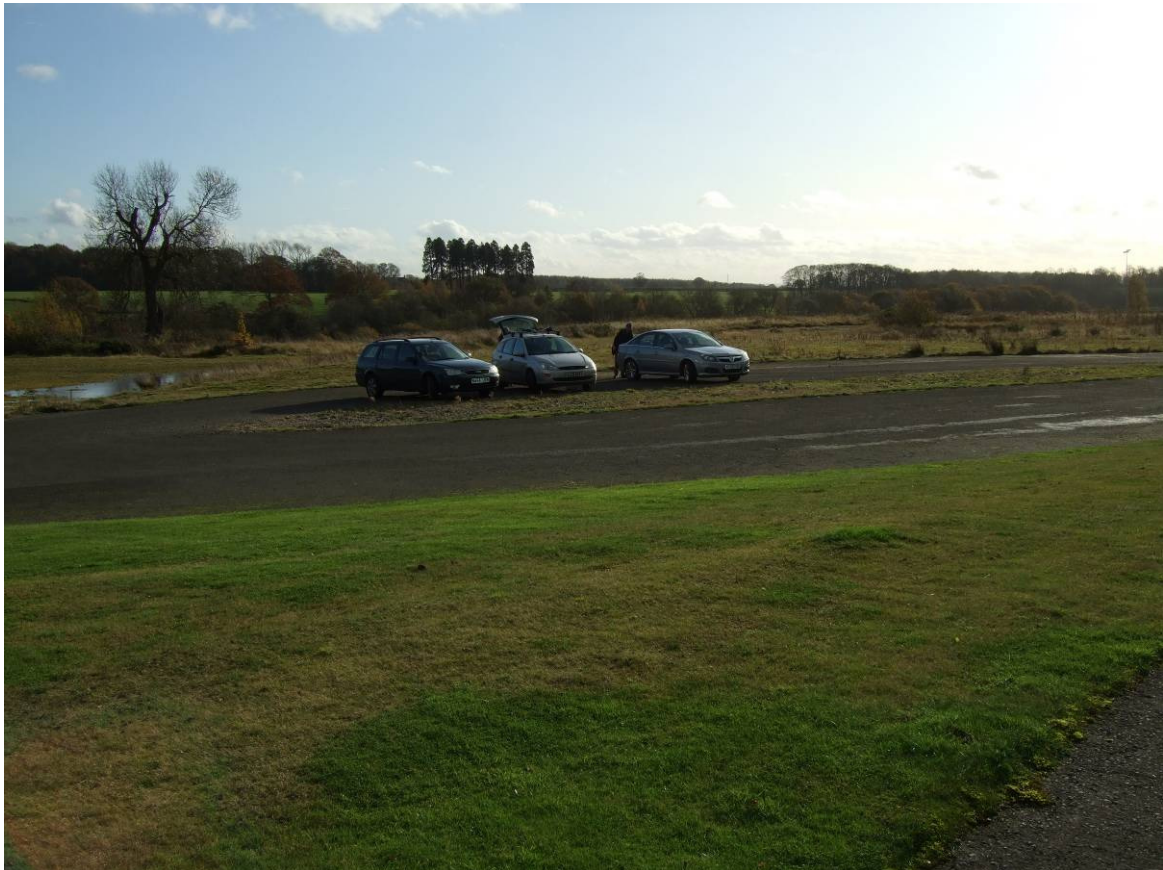
Photograph 2 Panorama from north west corner
