Tutbury East Staffordshire

Phase I Desk Study For Peveril Homes Limited

Project No: 29197		Date: 17 th November 2009				
Issue/revision	Prepared by	Checked By	Approved By			
	Christopher Harris BSc (Hons) FGS Graduate Geo-Environmental Engineer	Richard Spencer BSc (Hons) MEng MSc Director	Richard Spencer BSc (Hons) MEng MSc Director			
Comments

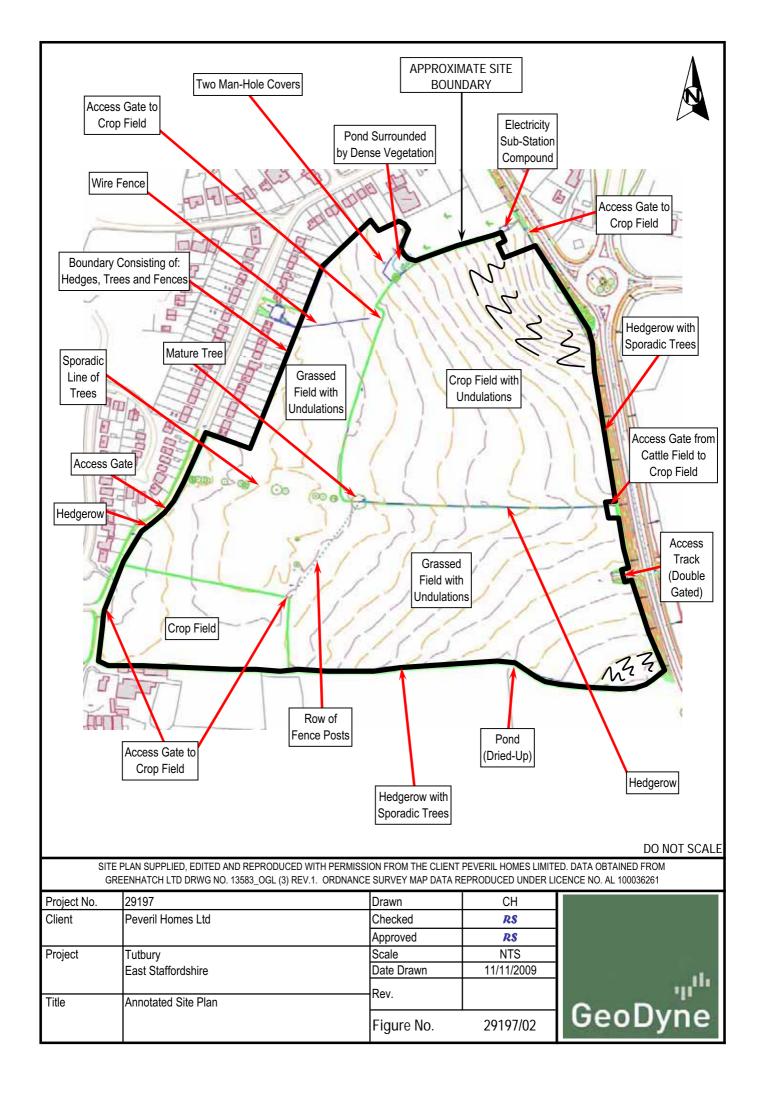
Annotated Site Plan (Figure No. 29197/02)

A site visit was undertaken on 9th November 2009. At the time of our visit the site comprised a mixture of arable and pastoral farmland. Arable crops were present in a large field in the north-east and a smaller field in the south-west. The remainder of the site was grassed with grazing cattle present. Ground levels fell gently from a high point at approximately the centre of the site towards the boundaries. In the north-east, the fall in ground level steepened to meet Burton Road at the lowest point of the site.

The north-eastern part of the site comprised a large crop field with small undulations. A hedgerow – with large metal gates: one in the eastern extent and another towards the north of the site – separated the large crop field from the rest of the site. A mature tree was noted at approximately the centre of the site within the hedgerow. A pond, surrounded by dense vegetation of trees and bushes, was observed in the north of the site next to the large crop field. Two man-hole covers were noted adjacent to the pond within the north-western field, suggesting the presence of buried services in this locality.

The north-west of the site comprised an area of grass very gently sloping down to the north-east with undulations (orientated approximately north to south). A wire fence was noted leading from the north-western boundary into the field. The large metal gate in the north of the site allowed access from this area into the large crop field. A line of discontinuous trees, sporadically positioned, led from the western boundary towards the centre of the site.

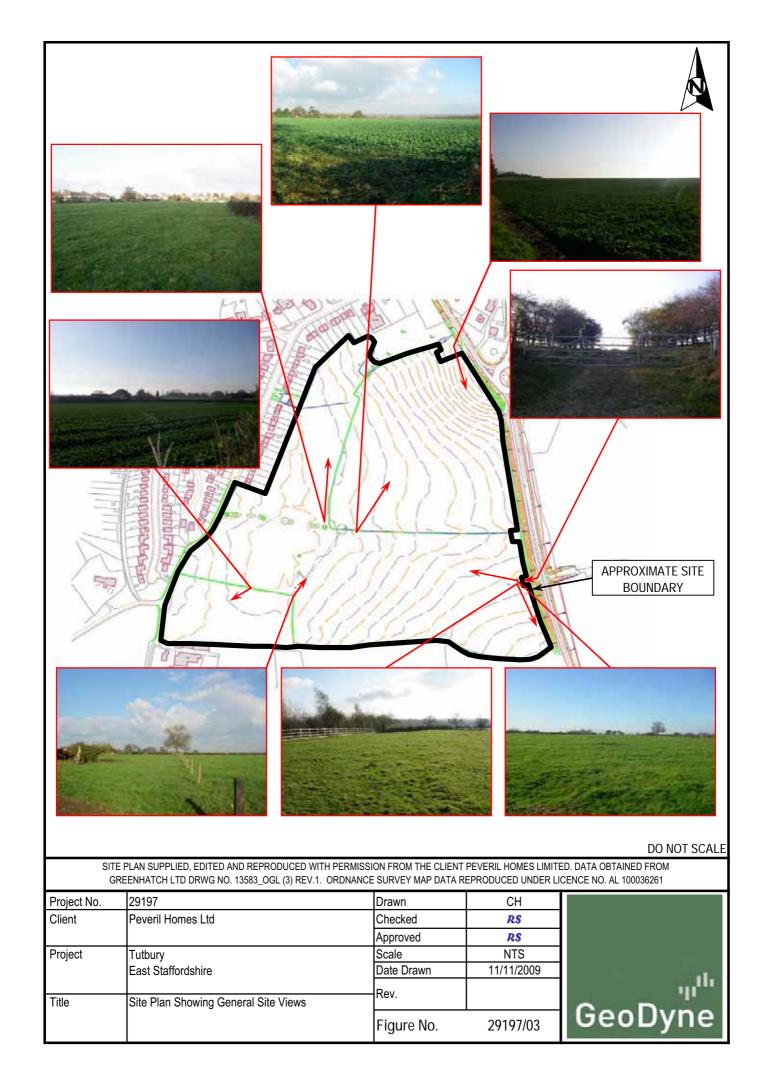
Site Plan Showing General Site Views (Figure No. 29197/03)

An annotated site plan (Figure No. 29197/02) is included as Appendix II of this report, with a plan showing general views of the site (Figure No. 29197/03) included as Appendix III. Selected plates are included as Appendix VI of this report.

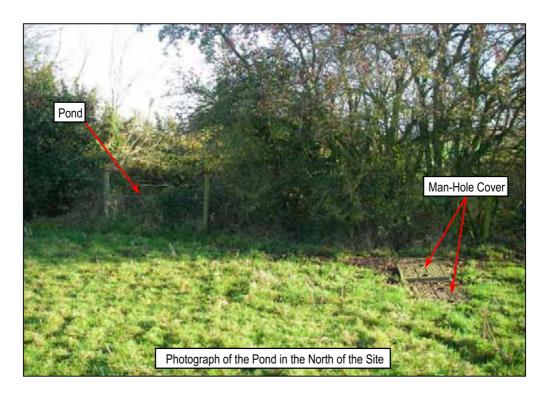
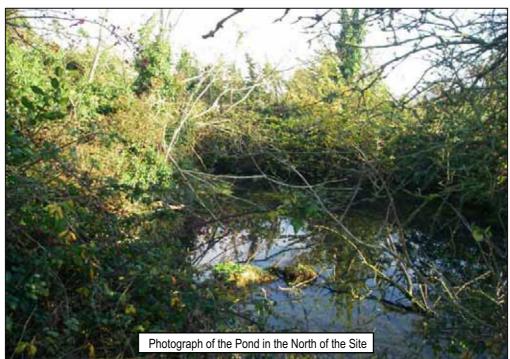
Project No.	29197	Drawn	СН
Client	Peveril Homes Ltd	Checked	RS
		Approved	RS
Project	Tutbury	Scale	NTS
	East Staffordshire	Date Drawn	13/11/2009
Title	Photographs of the Pond in the North of the Site	Rev.	
		Plate 1

- Historically, the site has been undeveloped with the exception of field boundary changes which altered the site from several smaller fields to three larger fields. The historical map publications indicated the presence of a pond in the south-east of the site c.1883 until c.1992. This is likely to have been backfilled. Another pond is also indicated by the historical maps to be present in the north of the site since c.1883 (and was observed during the site visit).

Based on the foregoing, it is recommended that further investigation is carried out in the vicinity of the former pond. This would aim to determine whether any significant depth of Made Ground is present which may be a potential source of ground gas. If present, localised gas monitoring of the site may be necessary in the vicinity of the pond.

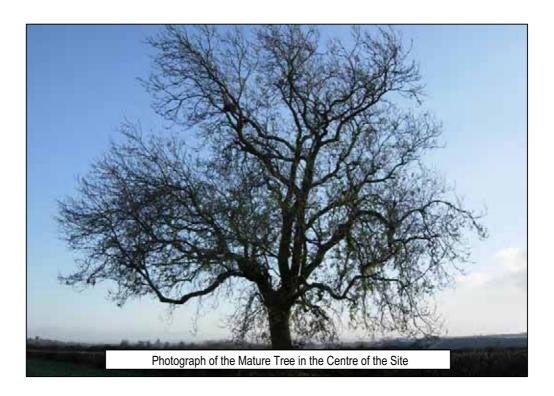
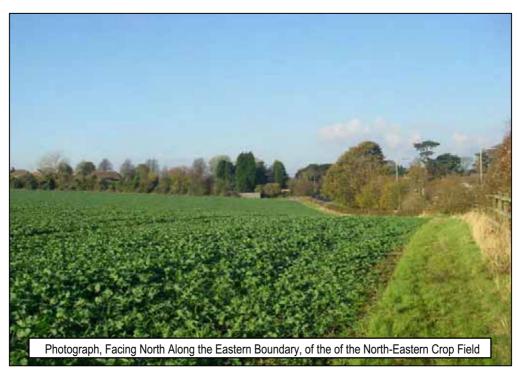
Project No.	29197	Drawn	СН
Client	Peveril Homes Ltd	Checked	RS
		Approved	RS
Project	Tutbury	Scale	NTS
	East Staffordshire	Date Drawn	13/11/2009
Title	Photographs of the North-Eastern Crop Field and	Rev.	
	the Mature Tree in the Centre of the Site	Plate 2

The site contains a number of trees, some of which are mature, particularly at the extremities of the site and also in a discontinuous line from the western boundary to the centre of the site. Foundation designs in cohesive strata may need to be adjusted in accordance with NHBC Standards Chapter 4.2 'Building near trees', where building near existing, proposed or recently removed trees.

It was noted that several mature trees were present locally across the site and around the sites perimeter. We would recommend that an arborist survey is undertaken prior to development.

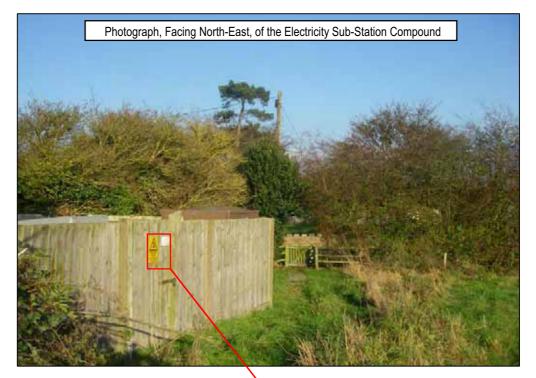
Project No.	29197	Drawn	СН	
Client	Peveril Homes Ltd	Checked	RS	
		Approved	RS	
Project	Tutbury	Scale	NTS	
	East Staffordshire	Date Drawn	13/11/2009	
Title	Photographs of the Electricity Sub-Station	Rev.		
	Compound	PI	Plate 3

Additionally, immediately adjacent to the north-east of the site, an electricity sub-station (within a secure compound) was identified. The sub-station compound was provided with an 'Environmental Awareness' notice stating that the equipment is 'PCB contaminated'. Selected pictures are appended.
