Phase 1 Habitat Survey & Protected Species Scoping Report

_ Dove Way, Uttoxeter, Staffordshire

Final Report

Report Number: P36.T46.11

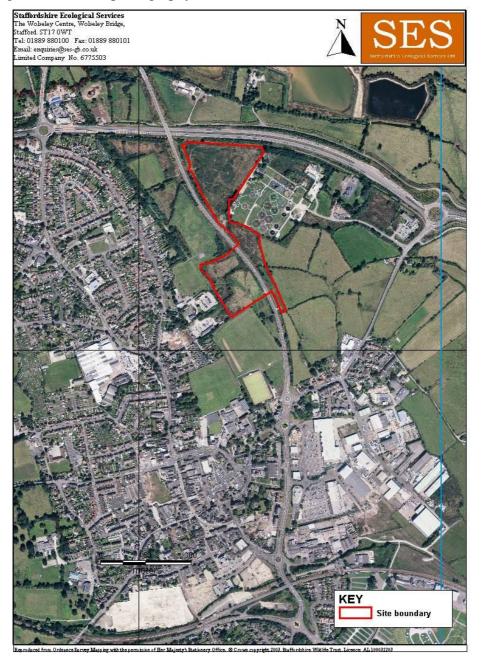
Figure 2.2: Aerial photography

Using aerial photography (Figure 2.2), the broad habitat types within 500m of the site boundary were determined to be:

- Semi-improved Grassland
- Scrub
- Tall herb and fern
- Standing open water (pond, shallow ditch)
- River, streams (Running water)
- Boundaries & linear features
- Built-up areas

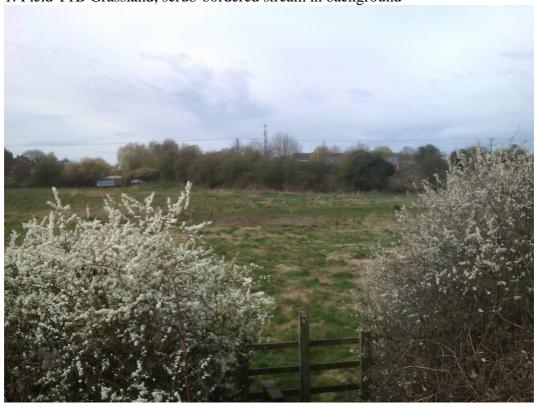
some extent within each field with field T1A having a more ruderal and herb-dominant sward whereas the other fields within the site (T1B, T6, T9, T14 & T16) were grass dominant. The site's grassland has developed into species-poor, rank grassland sward and varies relatively slightly in its species composition throughout these areas. The lack of management has resulted in the dominant grass sward consisting of cock's-foot (*Dactylis glomerata*) and false oat-grass (*Arrhenatherum elatius*). Other grass species such as creeping red fescue (*Festuca rubra*) were locally abundant.

1. Field T1B Grassland; scrub-bordered stream in background

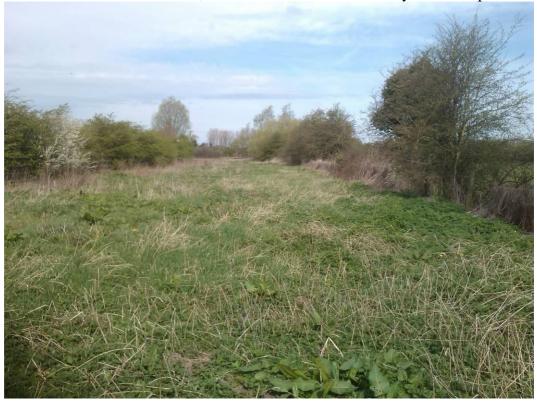
Young Himalayan balsam (*Impatiens glandulifera*) was thought to be seen in field T1B, but the plant was notably abundant at T5. As the plant was at seedling stage and less noticeable due to the timing of the survey, further checks to determine the extent of its spread would be advisable. A stand of Japanese knotweed (*Fallopia japonica*), which appeared to have undergone some eradication management, was seen at T13 as well as on the access road into the site from the recycling facility (T14).

2. Field 6 – view toward north; narrow south end with Himalayan balsam present

Himalayan balsam was noted onsite, but as it was quite young at the time of survey, the extent of its spread could not easily be defined. Japanese knotweed was also present (T13 and off-site at T15). The applicant may wish to commission a further survey be carried out from which a method statement could be developed for works affecting, or near to, these two species. The Environment Agency can provide the current best practice for the control of Himalayan balsam. The Environment Agency guidelines 'Guide for the control of invasive weeds in or near water' (Environment Agency, 2003) detail several options for the control of Himalayan balsam within a development site. As it is an offence to a cause Japanese knotweed to spread i.e. 'grow in the wild' and as it is a controlled substance, it is advised that the applicant liaise with the Environment Agency on this matter. Further information can be found on their website at http://www.environment-agency.gov.uk/business/sectors/31364.aspx.

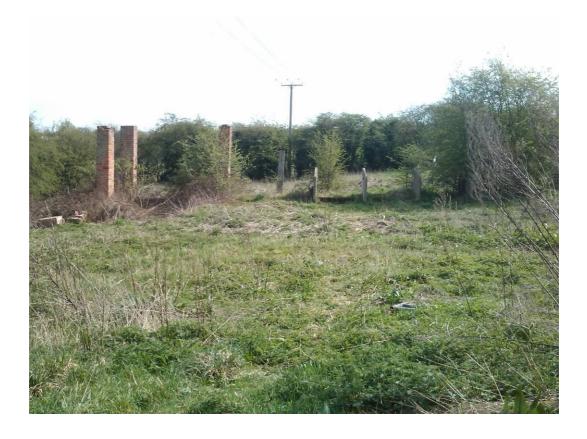
In field T1A, the brick-based foundation of a small stable building was noted.

3. Scrub around Field 1A and building remains

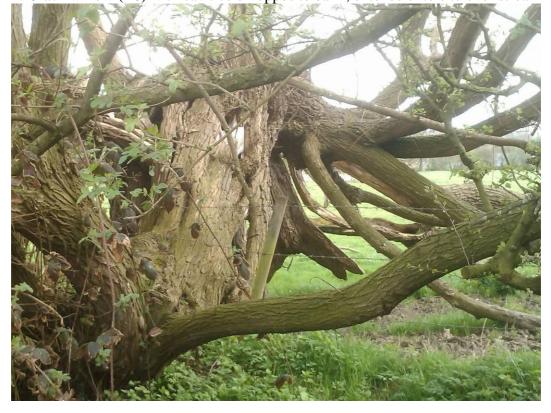
The fallen crack willow tree (marked as T8 on Figure 4.2: Phase 1 Habitat Map) has potential as a bat roost due to its size, location and number of holes and cavities. This tree should be retained within any development proposals.

4. Crack willow (T8) with cavities on opposite bank; extends onto site over stream

The crack willow tree (marked as T8 on Figure 4.2: Phase 1 Habitat Map) has potential as a bat roost due to its size, location and number of holes, cavities and fissures. However, if this tree is to be felled, dusk/dawn bat surveys and a relevant mitigation strategy should be put in place prior to felling. Part of the mitigation strategy may involve the application for a Natural England License for Development.

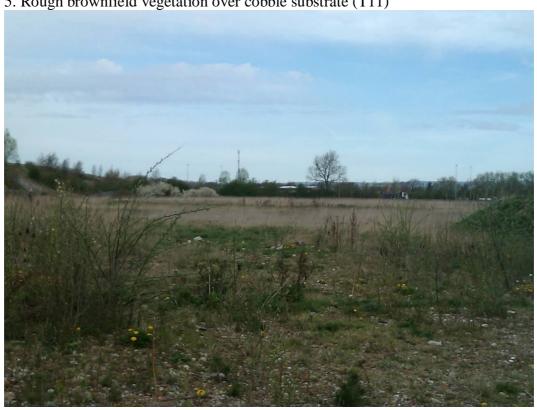
At the south of T14 was an area of brownfield vegetation on a pebble/cobble substrate (T11). The area had colonised with goat willow (*Salix caprea*), young Scot's pine (*Pinus sylvestris*), teasel (*Dipsacus sylvestris*) and various tall ruderals as well as a number of typical brownfield plants. A vegetated soil mound sat in the east of this area.

5. Rough brownfield vegetation over cobble substrate (T11)

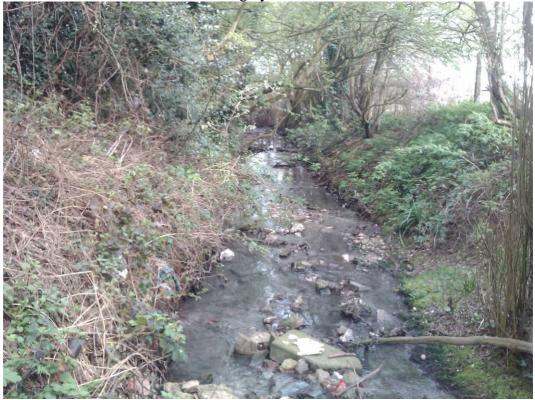
6. Stream corridor with discoloured, grey water, rubbish and rubble

Improvements to the stream could include: the provision of well-vegetated margins; avoiding introduction of chemicals/pesticides into stream during construction and operational stages; cleaning out the rubbish, maintaining stream connectivity; tree and scrub management along the stream; re-grading of the bank to create shelving for aquatic plants (increases flow, reduces silt and provides fish spawning substrate); using soft engineering techniques to protect/stabilise banks; control of invasive species, avoid building close to stream, ensure the watercourse if a 'feature' of the development, etc. The above-mentioned organisations should also be able to provide advice on improvement of stream habitat.

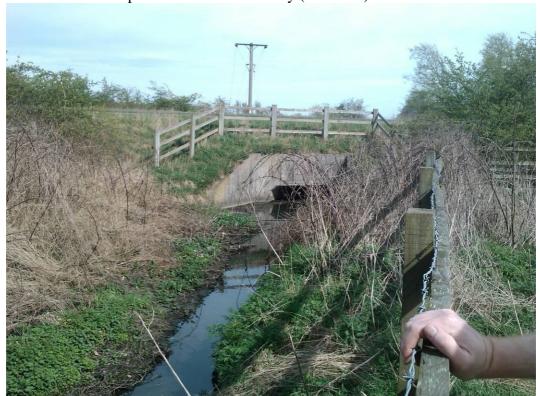
7. Stream where it passes beneath Dove Way (west side)
