**Bat and Bird Survey for,
Mr. M. Chappell.
Building at,
Yoxall Lodge,
Scotch Hill,
Newchurch,
Hoar Cross,
BURTON UPON TRENT,
Staffordshire,
DE13 8RL.**

**Map Ref SK 1566 2205
11th February 2019.**

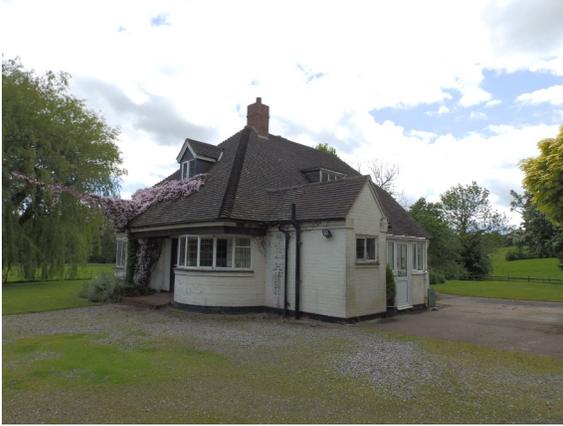
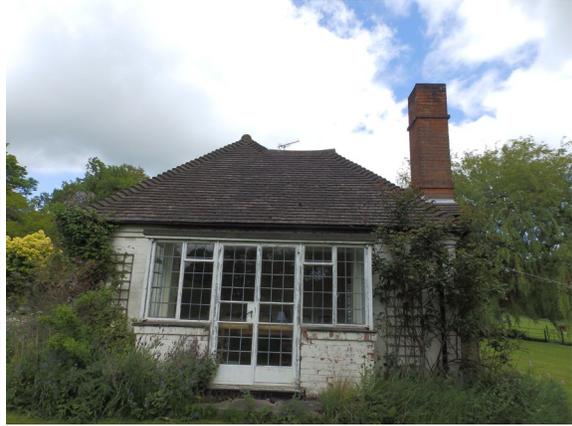
Yoxall Lodge is a four bedroom two storey dwelling with painted solid brickwork. The roof has a timber structure and is covered with plain tiles. There is a bitumous underfelt on the roof.

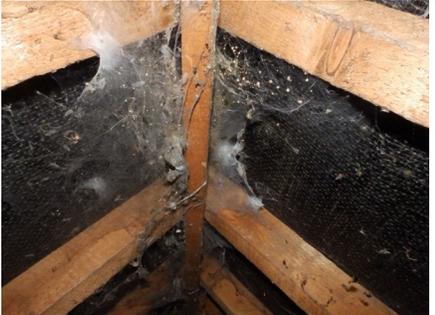
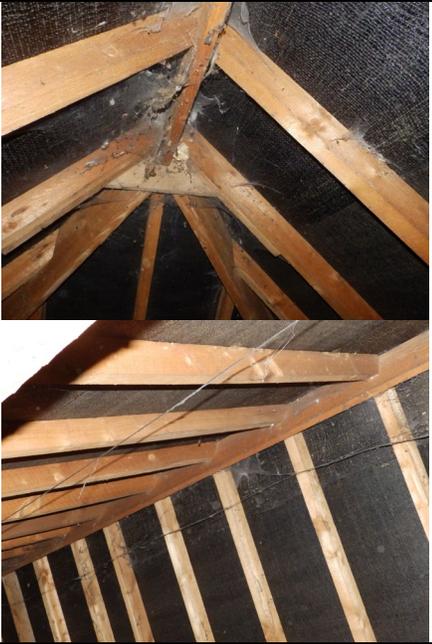
Feature.	Evidence of bats.	Likelyhood of bats roosting.	Photograph.
Behind ridge board.	Bat droppings.	Definite. There is access for bats to the ridge board and there are cobwebs on much of the ridge showing little use by bats.

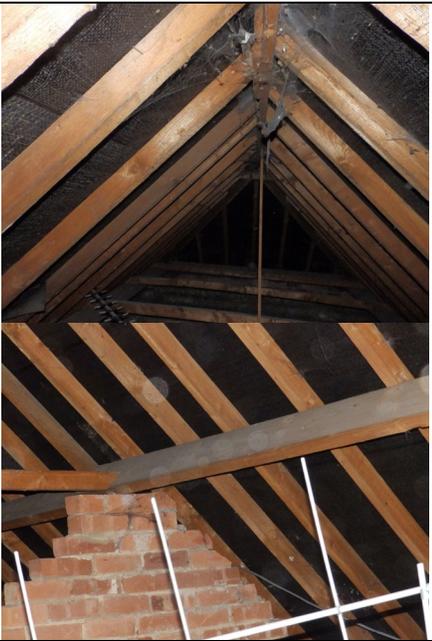
Feature.	Evidence of bats.	Likelihood of bats roosting.	Photograph.
In splits in timber rafters.	None.	None. Machine cut timbers.

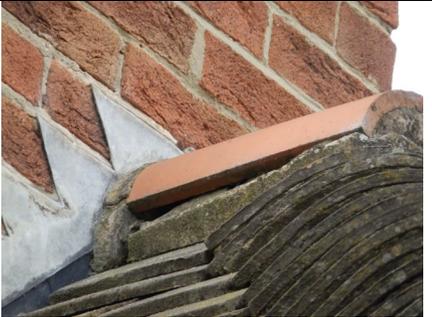
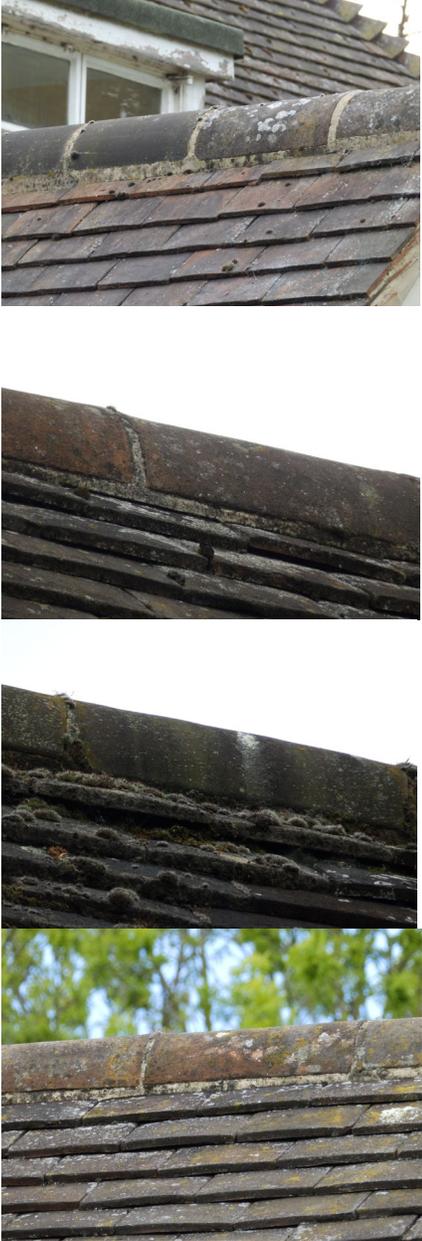
Under ridge tiles.	None.	Possible. There is one gap adjacent to the chimney that could be used by bats to access the space under the ridge tiles but this area is only one tile

<p>long. There are no other gaps on other sections of the ridge tiles.</p>

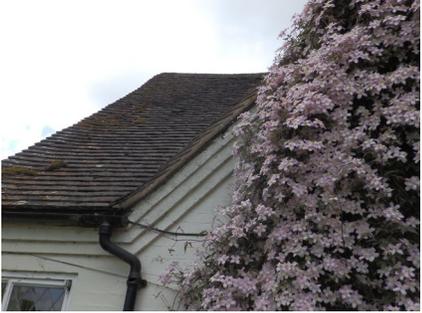
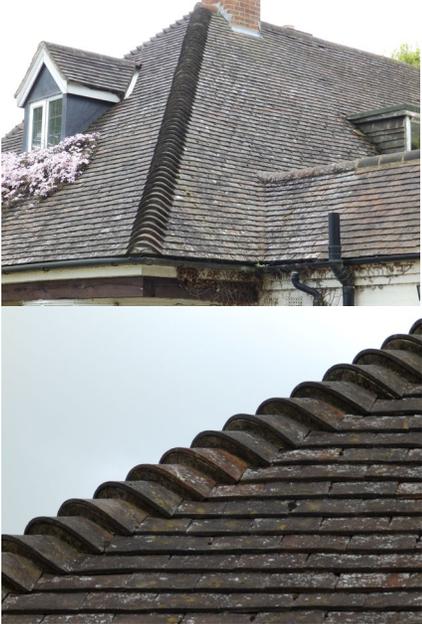
<p>Feature.</p>	<p>Evidence of bats.</p>	<p>Likelyhood of bats roosting.</p>	<p>Photograph.</p>
<p>Under bonnet tiles.</p>	<p>None.</p>	<p>None. There are small gaps where mortar is coming loose but they are too small to provide roosting for crevice dwelling bats and the one larger gaps do not</p>

continue under the bonnet tiles.

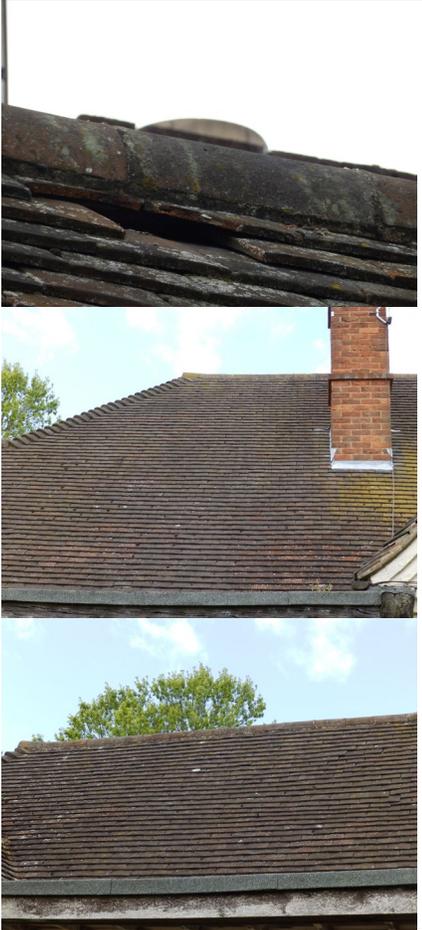
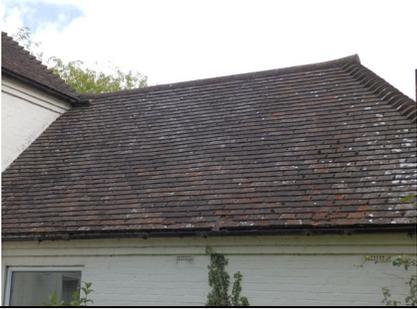
Feature.	Evidence of bats.	Likelyhood of bats roosting.	Photograph.
Under loose or missing roof tiles.	None.	Possible. There is one missing roof tile on the northern elevation.

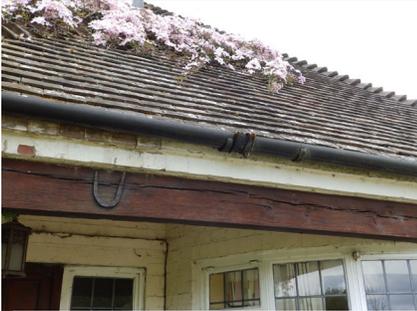
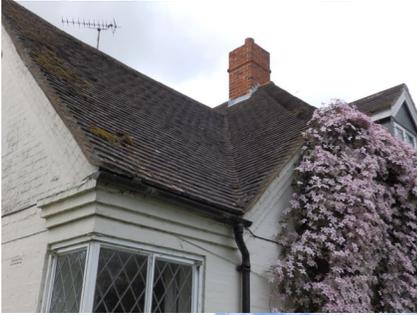
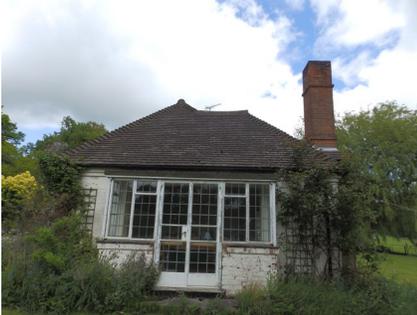
Feature.	Evidence of bats.	Likelyhood of bats roosting.	Photograph.
In eaves.	None.	Possible. The eaves on the majority of the property are brick with some areas corbelled. There is a ventilation gap at the eaves of the garden roof which gives access to the roof space but there is no evidence of bats using the space.

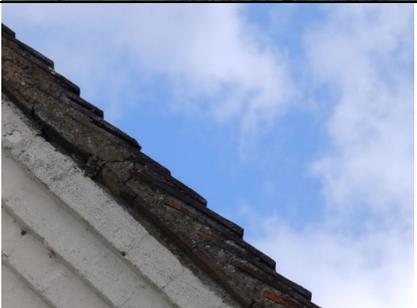
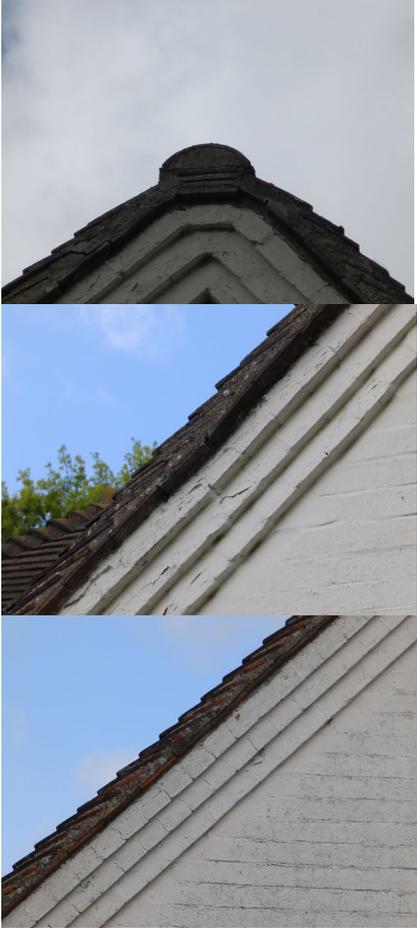
In verges.	None.	None. There is no access under the tiles.

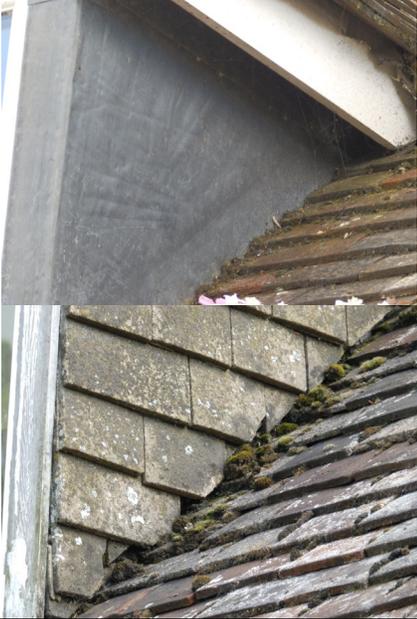
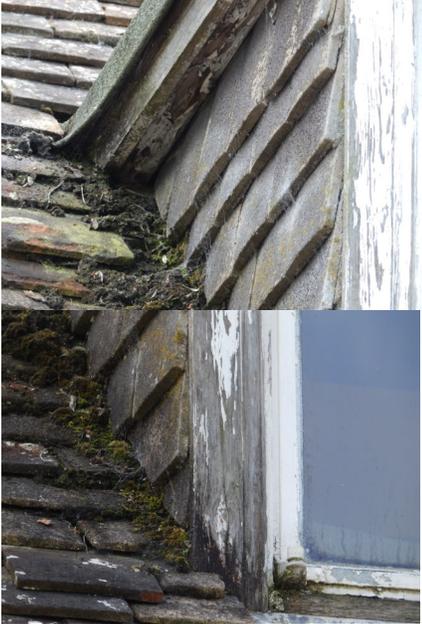
Feature.	Evidence of bats.	Likelihood of bats roosting.	Photograph.
Under lead flashings or hanging tiles on sides of dormer windows.	None.	Possible. There is no access for bat under the lead flashings but there are small gaps where hanging tiles have been cut that could give access and a place of shelter for individual bats.

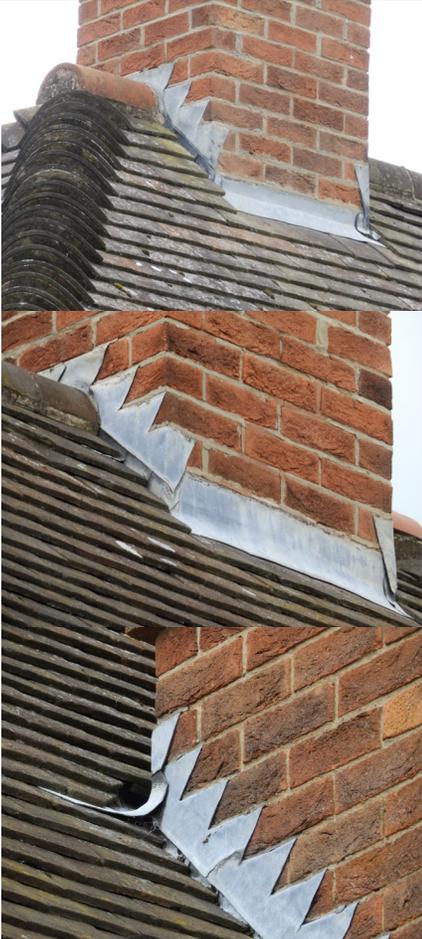
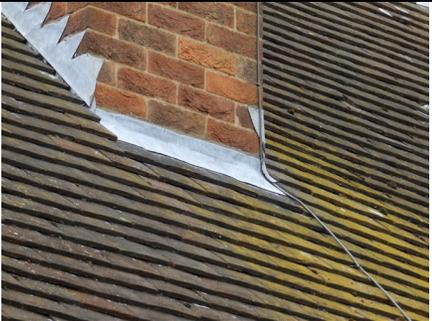
Feature.	Evidence of bats.	Likelyhood of bats roosting.	Photograph.
Under lead flashings around chimneys.	None.	Poor. There is no access for bats to the roof space or the rear of the roof tiles but there is one area where there is a temporary place of shelter for individual bats during periods of warm weather.

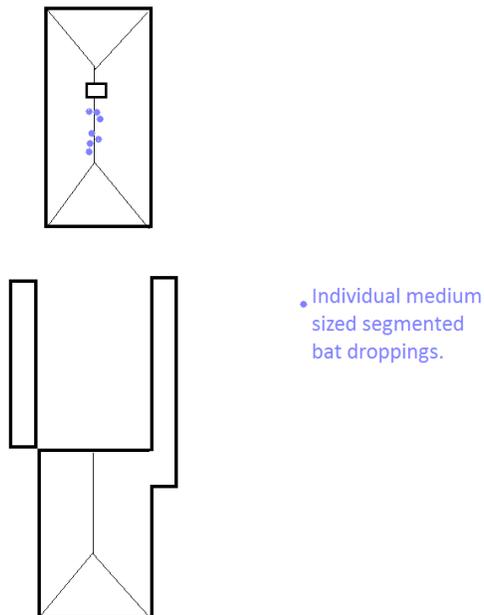
Bat droppings Yoxall Lodge.

7 medium sized segmented bat droppings were found in the roof space of Yoxall Lodge. The bat droppings varied in colour from grey brown to medium brown but none showed signs of being fresh and the grey/brown droppings were probably a number of years old.

The size and location of the droppings beneath the ridge board make it most likely that these droppings are from a Brown long eared bat.

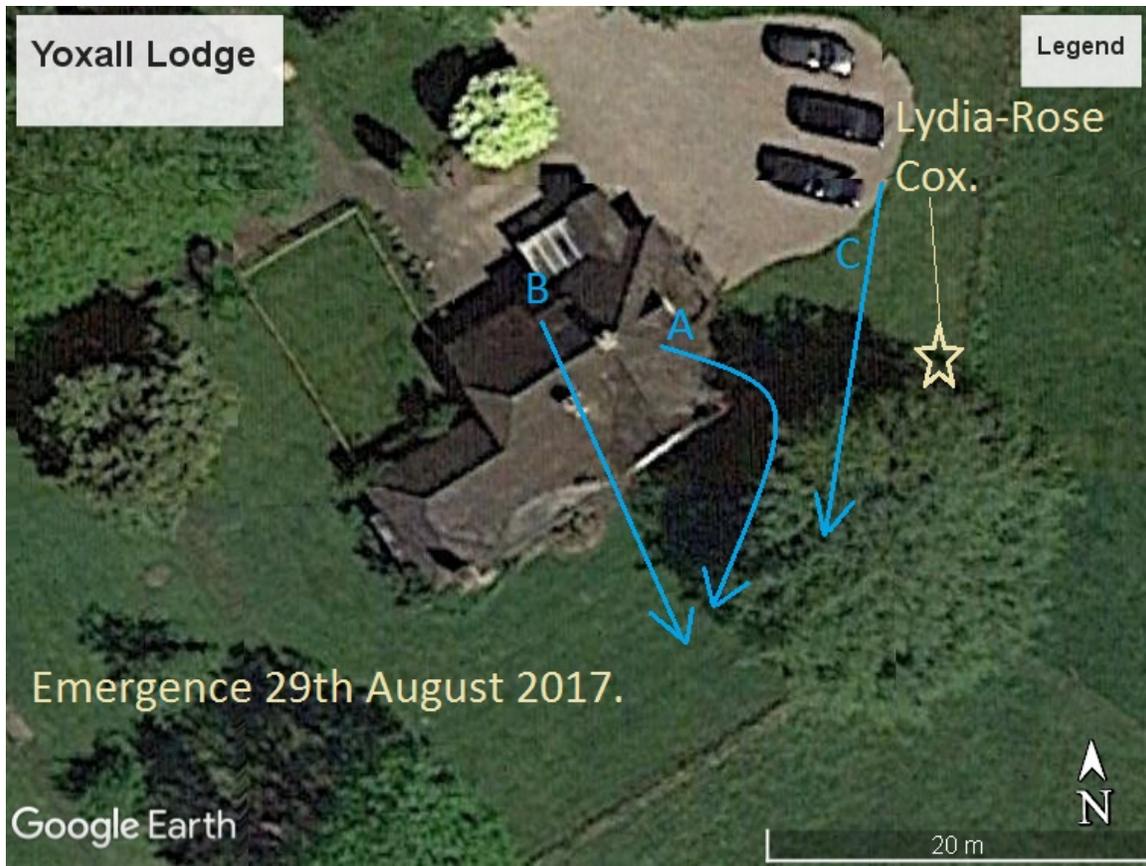
Analysis of the recordings from the bat detectors have confirmed the presence of Common Pipistrelle bats and Soprano pipistrelle bats.

The signal was not strong as the bats were only commuting across the site and not visible most of the time. The sonogram shows the typical 'hockey stick' shape for all pipistrelle echolocation calls, an initial frequency modulated downwards sweeping call followed by the constant frequency peak frequency area. The peak frequency can be seen to be around 45kHz on the peak frequency graph, confirming that the bat was a Common Pipistrelle.

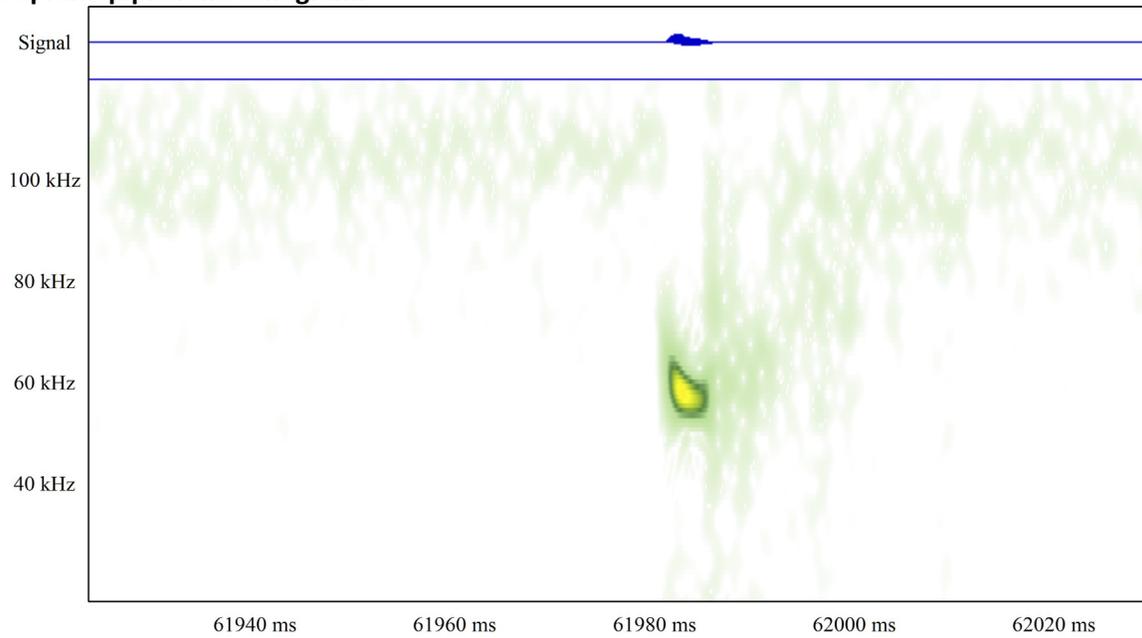
Soprano pipistrelle sonogram.

The Soprano pipistrelle peak frequency shows that the peak is around 55kHz.

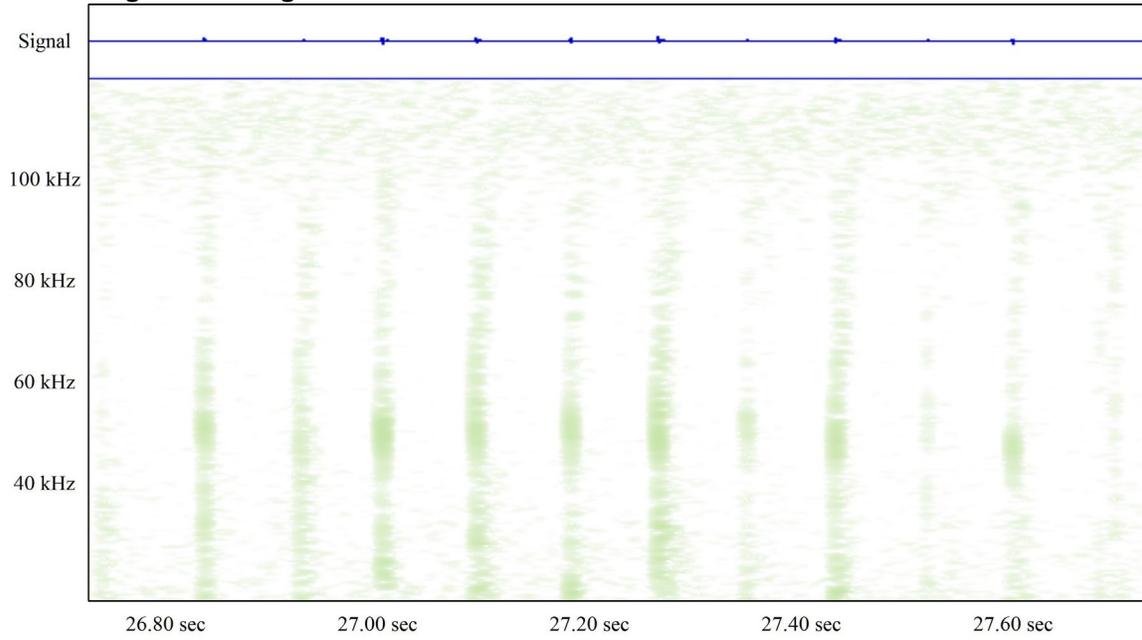
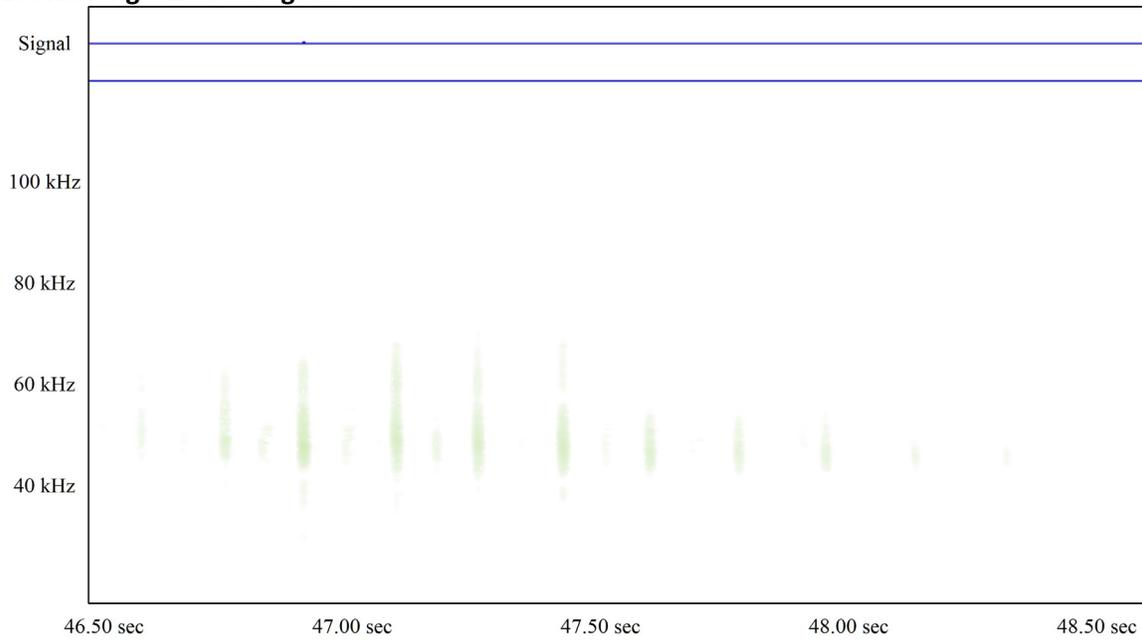
Brown long eared sonogram.

The Brown long eared bats heard have also been confirmed by sound analysis with the weak frequency modulated downwards sweeping call. The signal is weak because of the nature of the Brown long eared call.

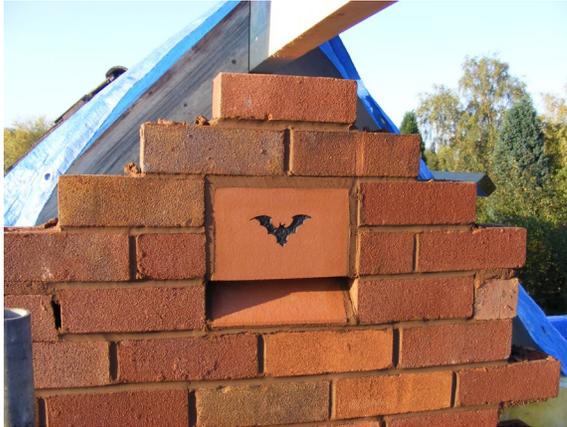
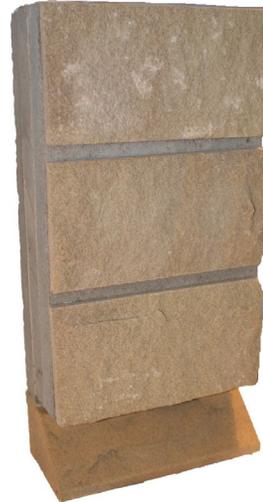
Brick built bat boxes.

A brick built bat box can be installed at the eaves of the eastern and western elevations of the new garages to be built adjacent to the dwelling, should planning permission be granted. These are constructed from brick or concrete blocks and are built into the outer leaf of brickwork. They can have facing bricks or be rendered. They provide no access to the cavity wall.

The eastern and western elevations have been chosen because the position will benefit from solar gain and will provide a warm roost for crevice dwelling bats.

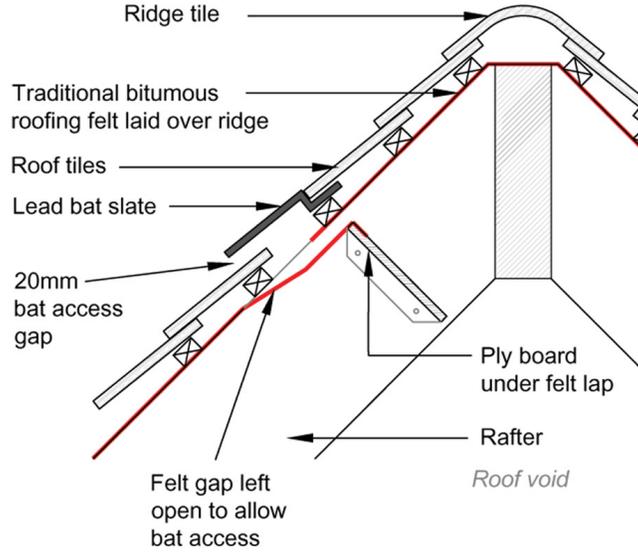
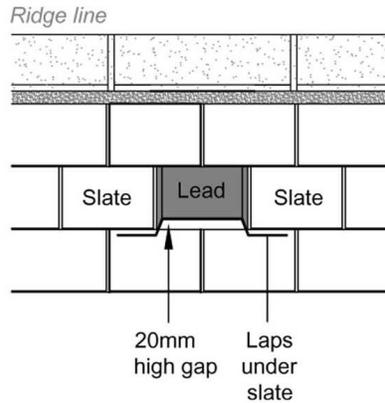
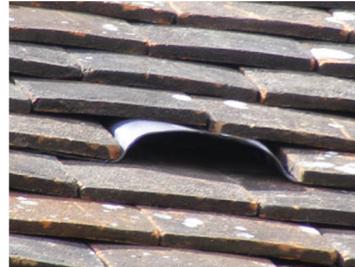
**BAT ACCESS 'SLATE'
DETAIL 1B - with access to
roof void**

SECTION: BAT ACCESS 'SLATE' 1B
Not to scale

Elevation: BAT ACCESS 'SLATE' DETAIL 1B
Not to scale

Bat slate built into slope

Photograph of bat slate

A new roost for Brown long eared bats can be created in the roof space of the garage. Access can be created by installing a lead bat slate on the eastern elevation close to the mature trees which will provide a commuting route and forage opportunities. The roofing membrane must be a traditional bitumous underfelt that is compatible with bat use.
