**The National Football
Centre**

Geo-Environmental Desk
Study Report

February 2010

Job number 209289-00

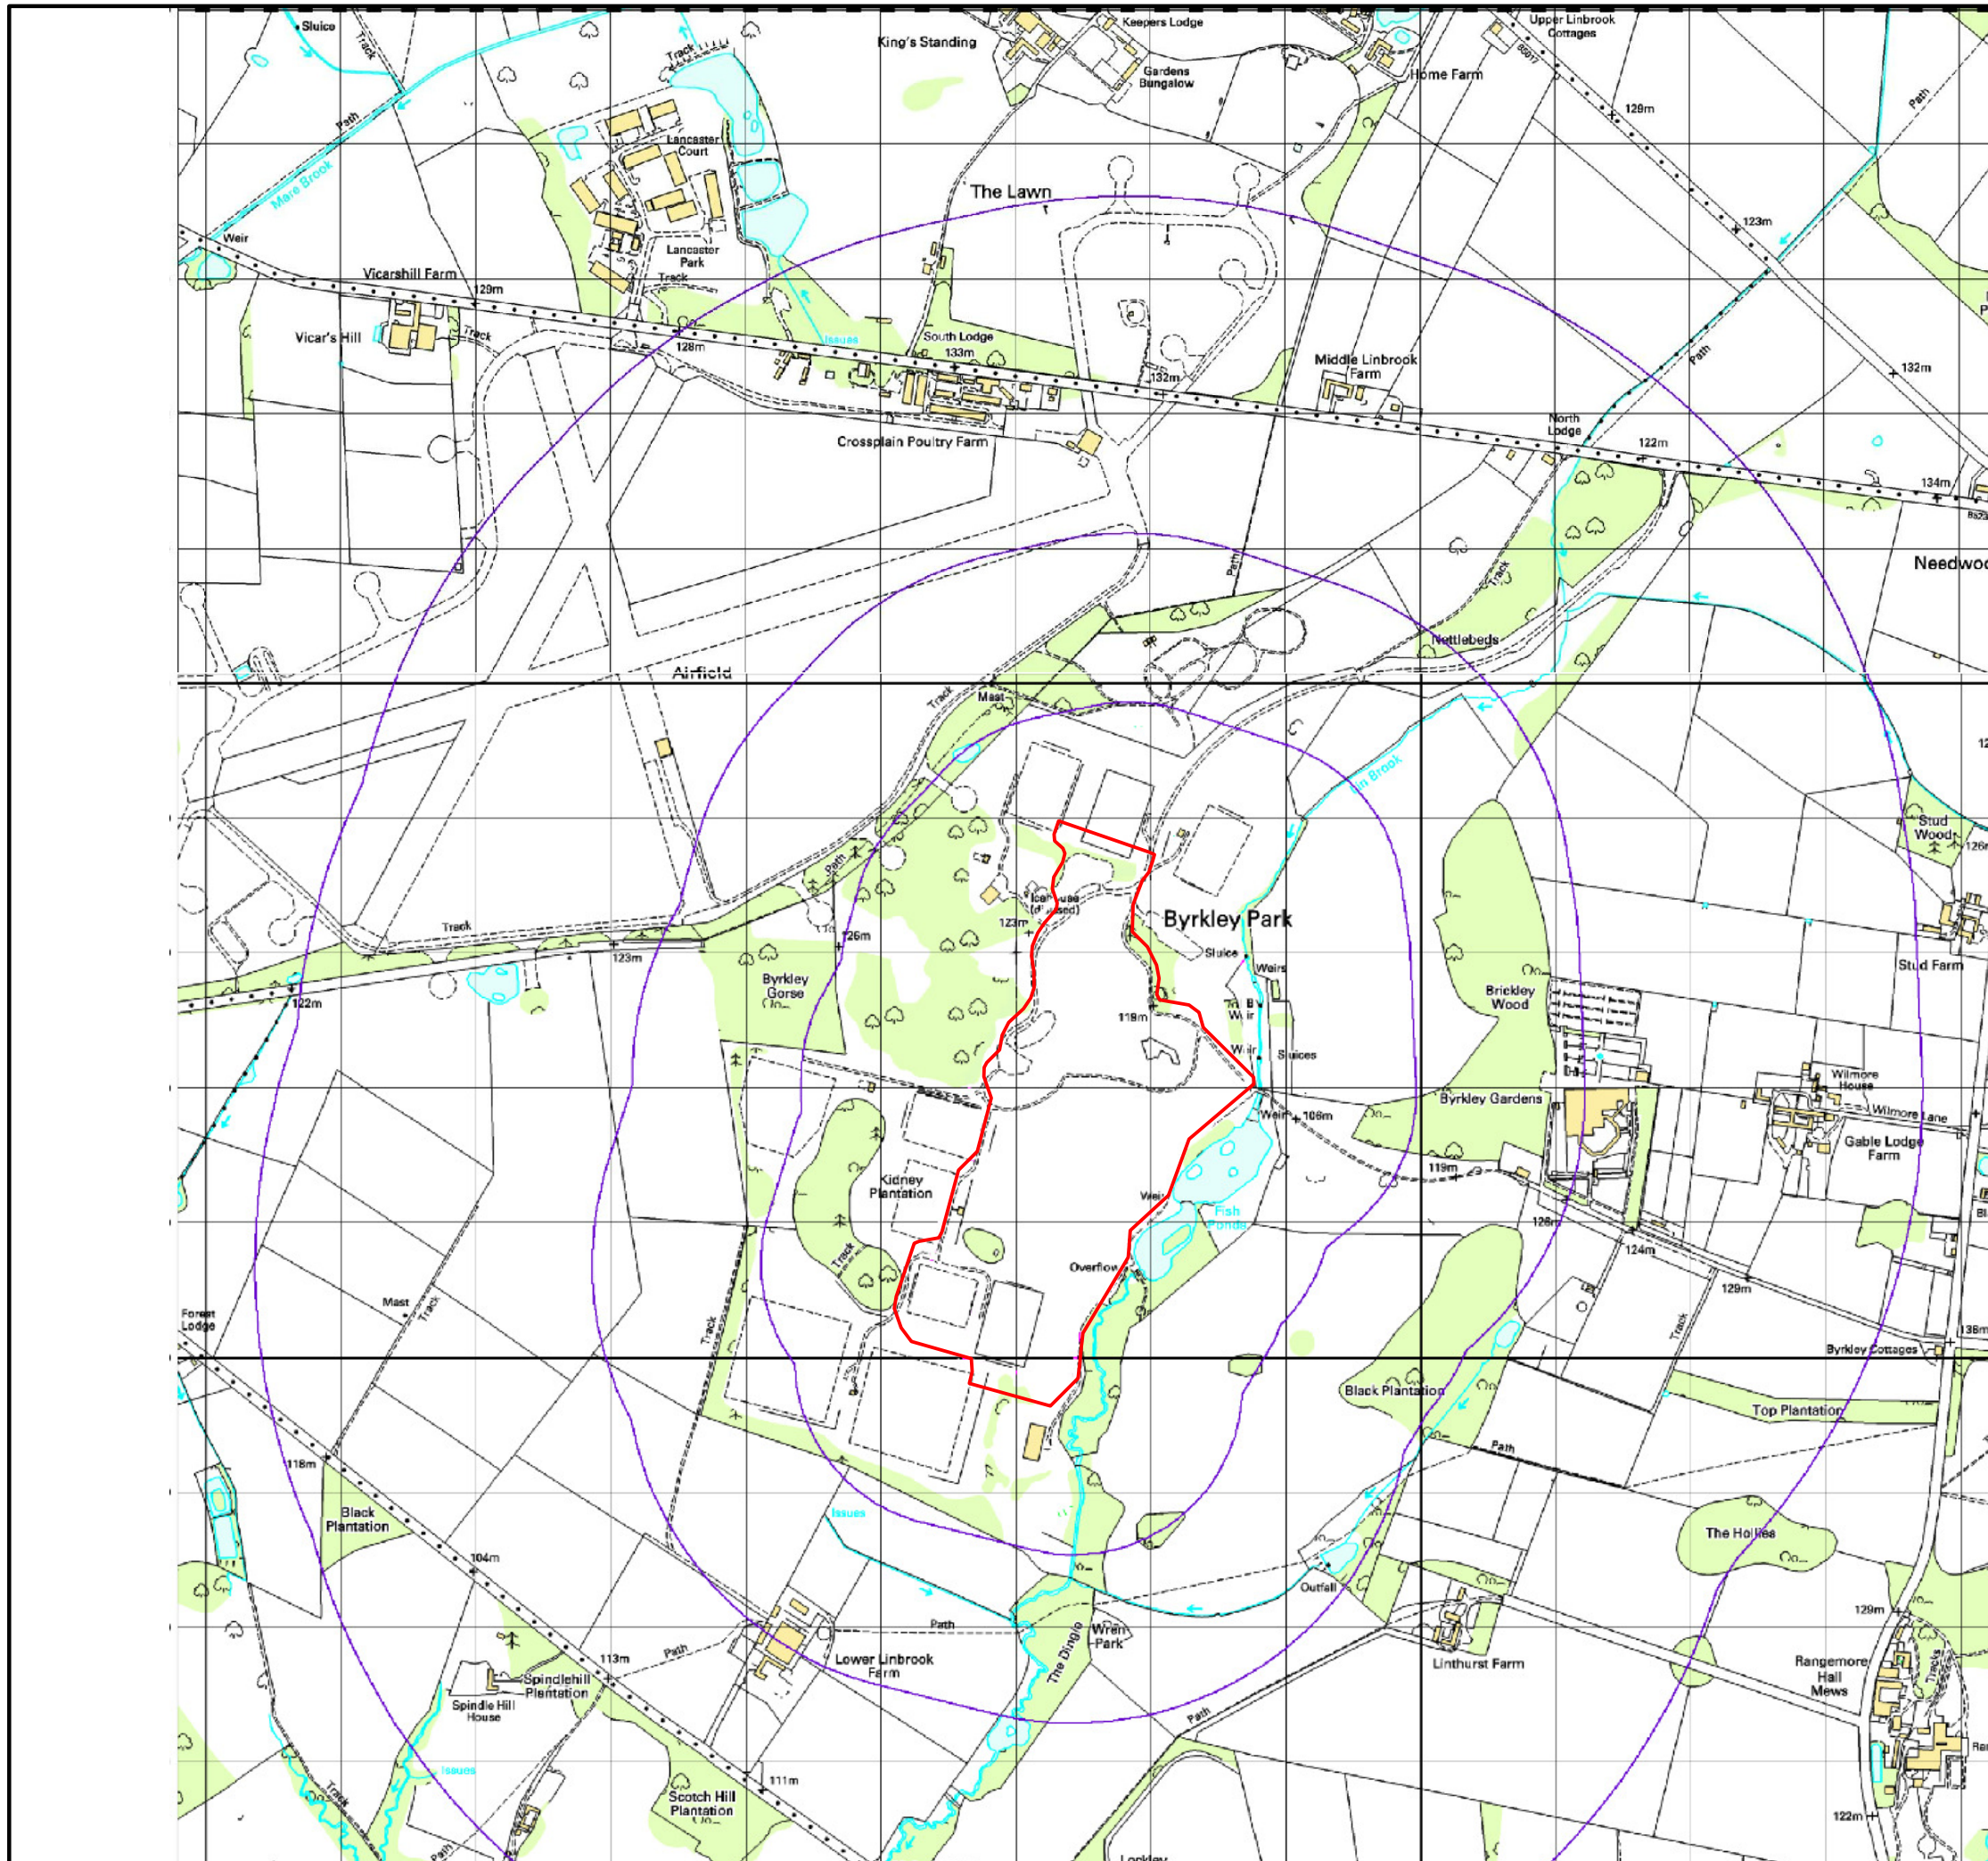
FIGURE 3

Site walkovers were carried out in November 2009 and January 2010. Features noted during the site walkover survey are annotated on Figure 3. A selection of photographs taken during the site walkover showing general views of the site are included in Appendix A. At the time of the walkover the site was predominantly covered with rough grassland sloping down to the east. An access road crossed the northern and western part of the site.

- Earthworks have been undertaken on the site as part of the 2002 previous development. This included the partial infilling of a valley in the centre of the site. This was in the area of the valley feature and boggy ground noted on Figure 3.

A foot and mouth burial pit is present beneath the western area of the site, Figures 3 and 4.
