**Appraisal of Existing Condition
and
Commercial Viability for Conversion
in respect of
redundant agricultural and former kennel/cattery buildings
at
Springlands Farmhouse
Toothill Road
Uttoxeter
Staffordshire
ST14 8JU**

**Prepared by
I G Whitfield BSc(Hons)MRICS**

Date of Report: December 2010

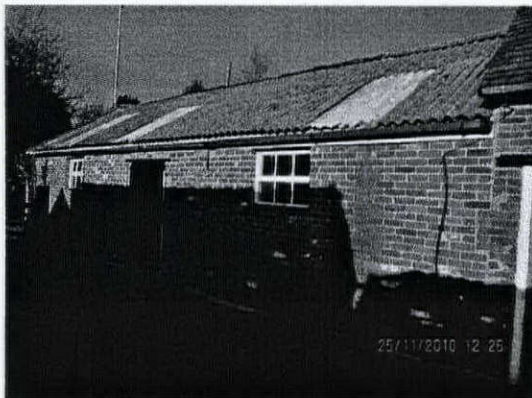
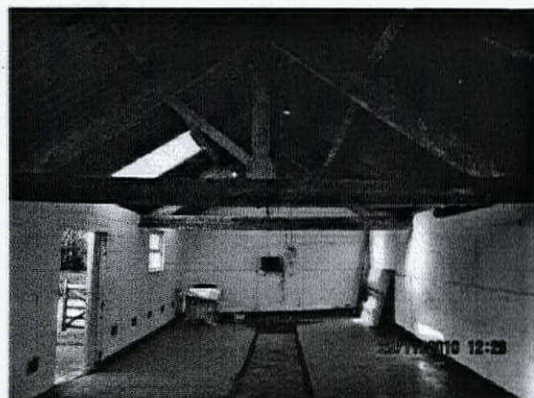
3.0 Building A

A vertical fracture of 4mm maximum width extends above the left hand doorway lintel end internally with a hairline fracture through mortar pointing externally. Hairline fractures extend beneath each window and above the right hand lintel end of the right hand window internally. This movement is not of structural significance and no remedial works are necessary.

The line of the rear wall does show a curve and an inward lean at the eaves to the centre of the elevation. This coincides with truss bearings suggesting that the damage was caused by the cranking of the original roof towards the front of the building. This will have resulted in the probable outward curve of the front elevation, the principal reason for its reconstruction. Completion of the latter has stabilised the rear wall.

Mortar pointing is generally satisfactory, although making good defective mortar and weathered brickwork to the left hand gable wall will be required in conjunction with refurbishment works.

Purlins show longstanding deflection and that centre purlin at the rear a significant split which has compromised its structural integrity. The rear left hand purlin adjacent has been replaced with a reclaimed timber of smaller 150mm x 75mm dimensions.

The present lightweight roof covering is adequately supported despite these defects. Nevertheless, it is anticipated that provision of a traditional tiled roof covering will demand replacement of the purlins and the raising of the truss bases to create improved headroom.

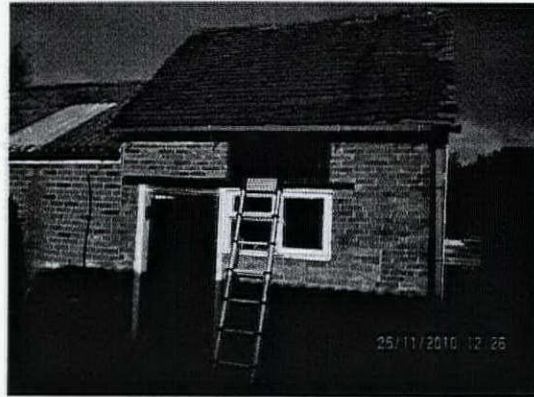
- 3.2.3 The 225mm solid brick front elevation of the end-bay is block bonded to the reconstructed front elevation of the building described above. An infill brick panel which is ill-matching has been added to the front elevation, together with a timber lintel supporting a panel of reclaimed traditional brickwork above. The upper brick panels show a slight outward lean consistent with longstanding roof spread, although the replacement brick panel has been reconstructed plumb to accommodate this. The degree of spread falls within normal tolerances and the elevation is sound.

The gable wall has exposed original 110mm half brickwork to the apex. This shows a slight outward lean, although not sufficient to threaten structural stability. The brickwork is in need of repointing and the cutting out and replacement of weathered bricks. The main lower section of the wall has a modern render finish which is undecorated. It is in sound condition, although in contact with underlying concrete and damp affected at the base.

The purlins and rafters are affected by active beetle infestation and the exposed purlin ends by wet rot. Conversion and refurbishment of the building may be expected to demand replacement of the roof timbers. Nail fixings of timber battens have corroded giving rise to evidence of slippage, particularly to the verges and eaves, and at the rear. A cement fillet provided at the junction of the main building has deteriorated, giving rise to consequent penetrating dampness in the rear storage room.

Internal walls of the kennel kitchen have plasterboard dry lining internally, the plaster having deteriorated as a result of rising dampness. The walls are plumb and vertical.

The 225mm brick wall leading to the rear compartment has a timber lintel above the doorway opening laid flat. There is a stepped hairline fracture above the door, although of no structural significance and the masonry remains sound. The walls of this compartment are of painted brickwork. The concrete floor is at the same level as the adjacent described above.

The small storage compartment has a raised brick floor. The internal walls and the internal face of the gable wall are in sound condition.

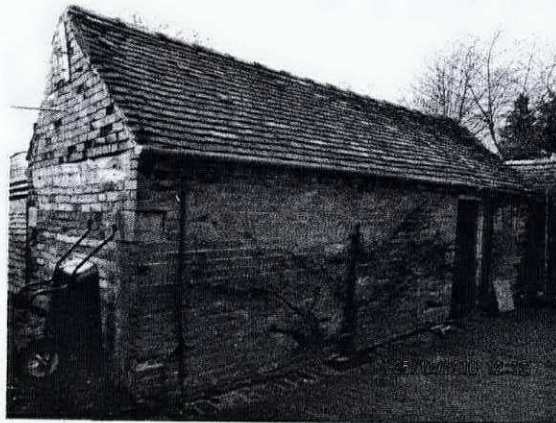
4.0 Building B

The infill brickwork to the underside of the timber beam is in sound condition.

The building has uneven concrete floor which it is anticipated will be replaced in conjunction with wider refurbishment and conversion work.

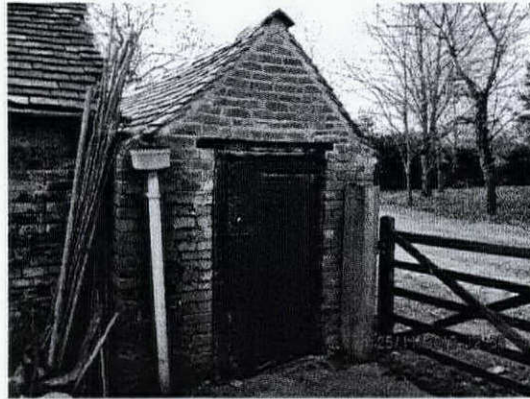
5.0 Building C

The building is of 225mm solid brickwork beneath a duo pitched and plain clay tiled roof. There is a doorway opening to the front gable and window to one side elevation.
